**Archaeological Assessment
Of the Monument Lake Fish Hatchery and Zoo (5LA.12777)
Las Animas County, Colorado**

**Anthony & Associates, Inc.
P.O. Box 271400
Fort Collins, Colorado 80527**

October 8, 2012

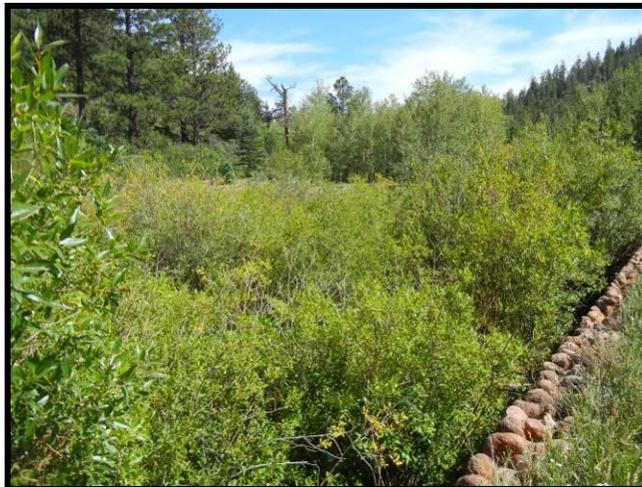
Figure 14. View to the southeast of a portion of Feature 14 (retaining pond) showing heavy vegetation growth, willows and some cattails, that prohibited pedestrian survey.

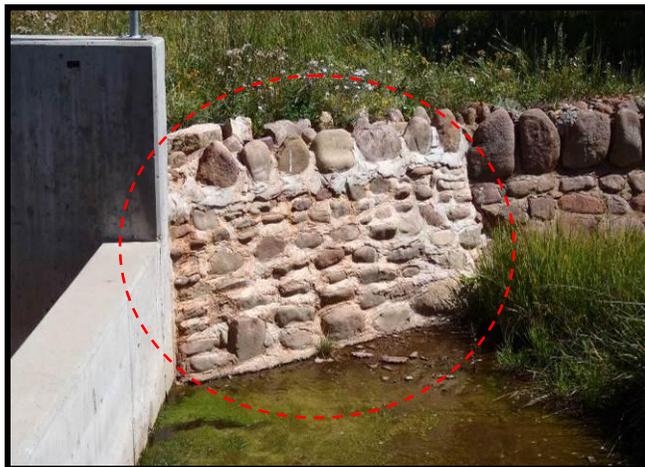
Figure 25. Repaired or reconstructed section of pond wall adjacent to the water supply station. View to the east of the east wall.

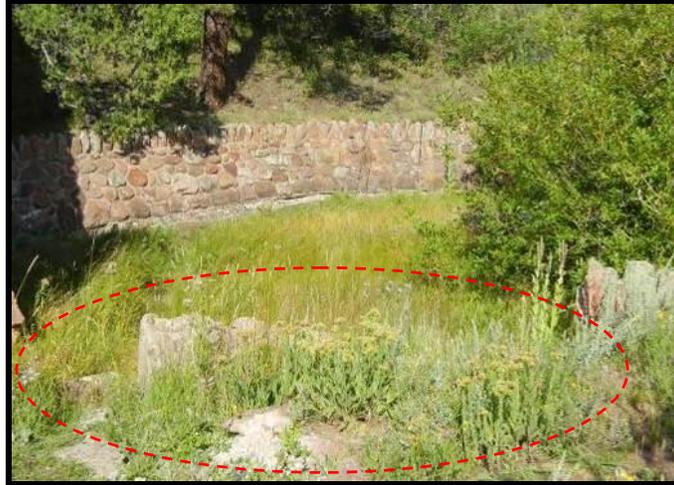
While in relatively good condition at the north half, the south portion of the central canal has some damage. The west wall of the canal has collapsed just south of the south pedestrian bridge to the zoo viewing area (Figure 34). This section is also the west wall of the zoo pond. Just south of the zoo pond gate, the west wall of the canal has toppled (Figure 35). It remains essentially intact, but has fallen over into the canal bed. This damage extends for approximately 100 feet. At the termination of the canal, water from the canal would have traveled through an informal drainage system to the Cherry Creek at the south end of the site.

Figure 34. An area of collapse on the central canal, west wall, at the zoo pond. View to the east.

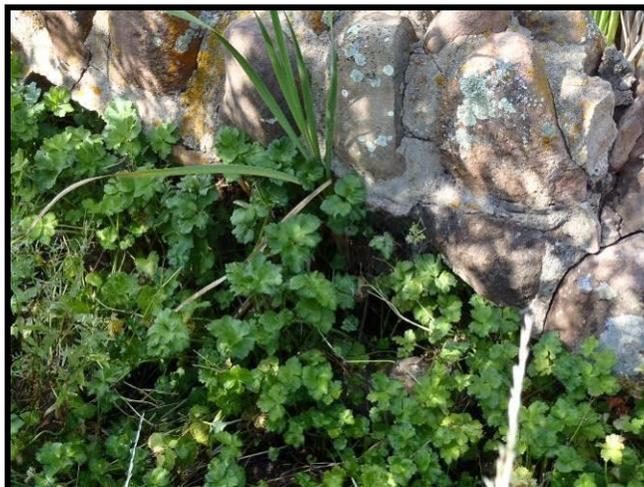
Figure 38. Damaged portion of the southern pond wall. View to the southwest.

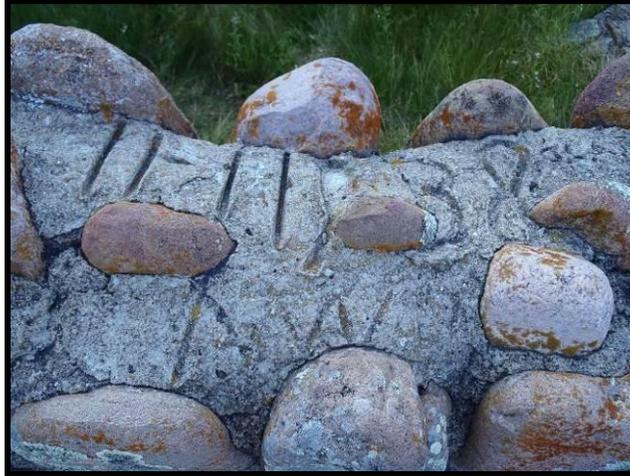
Feature 7 is comprised of two paired animal enclosures that were used to house bears. The exact date of construction is not known; they may have been completed in 1934-1935 along with the fish hatchery by CCC Camp SP-11 in conjunction with IWLA, or they may have been constructed at a slightly later date. An inscription on what appears to be a small repair along the south wall at the southern terminus of the viewing walkway reads, “11-11-38 A.W.D,” suggesting that the enclosures were completed by 1938 (Figure 39).

Figure 39. Inscription on a possible repair area, south wall of the zoo enclosure viewing walkway. View to the southeast.

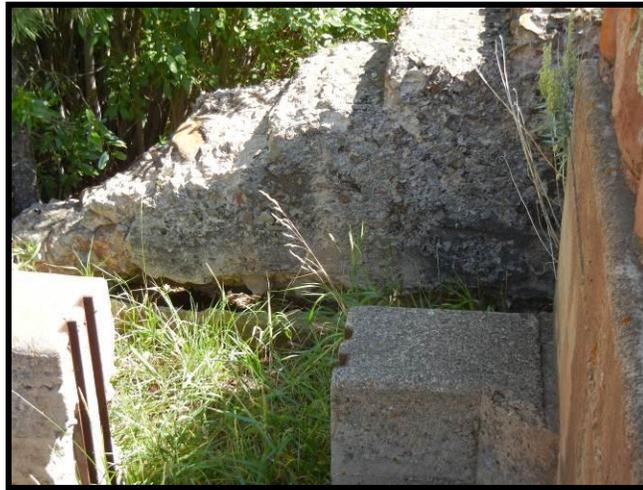
The raceway channel walls are constructed of wire-reinforced concrete. The channel walls are eight inches thick and 2 feet tall at the north end, and 3 feet tall at the south end of the pond. The walls extend approximately 60 feet and end in gated openings (Figure 61). Most of the raceway walls are in good condition, however, some exhibit evidence of spalling (Figure 62). The raceway pond extends another 5 feet to the south beyond the end of the raceway channel walls; a set of concrete stairs on the east and west perimeter walls delineate a poured concrete lip that spans the pond east-west and provides a boundary from the raceway to the retaining pond (Feature 14). The concrete stairs and lip are in poor condition (Figure 61).

Figure 61. Concrete stairs (background) and a water control gate (foreground) at the end of the raceway pond. View to the southeast.

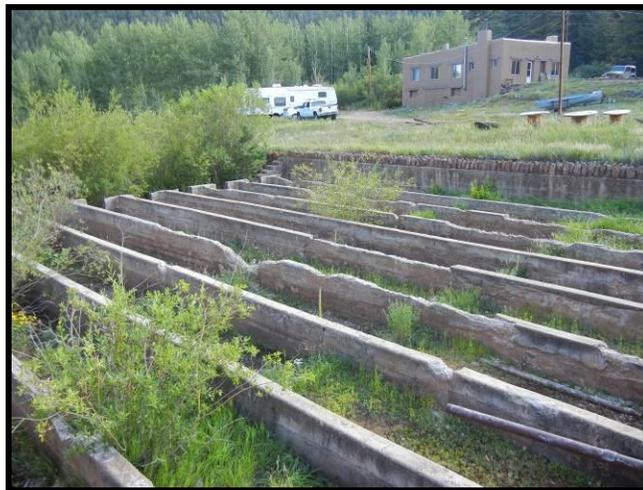
Feature 62. View of damaged raceway walls. View to the south.

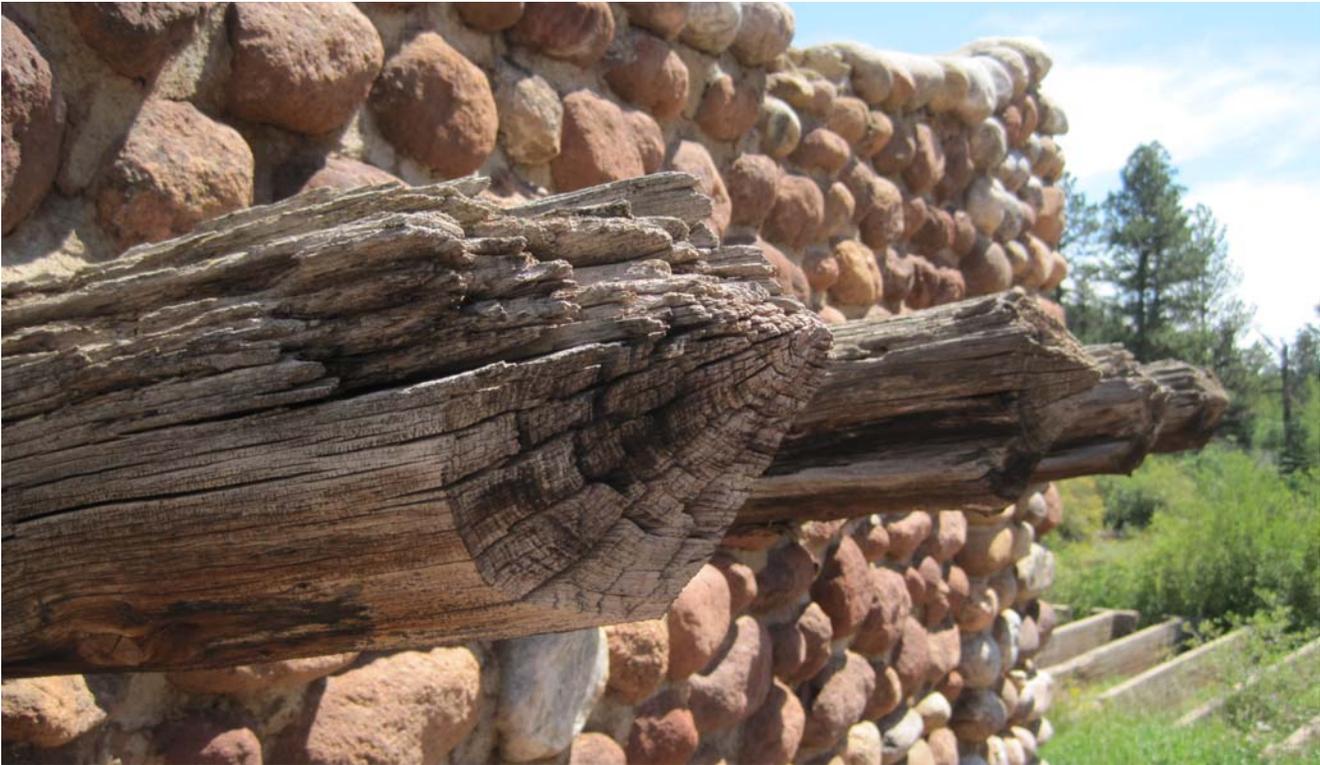
ML12 CLOSE UP VIEW SHOWING STONE CONDITION AND VIGA DETERIORATION

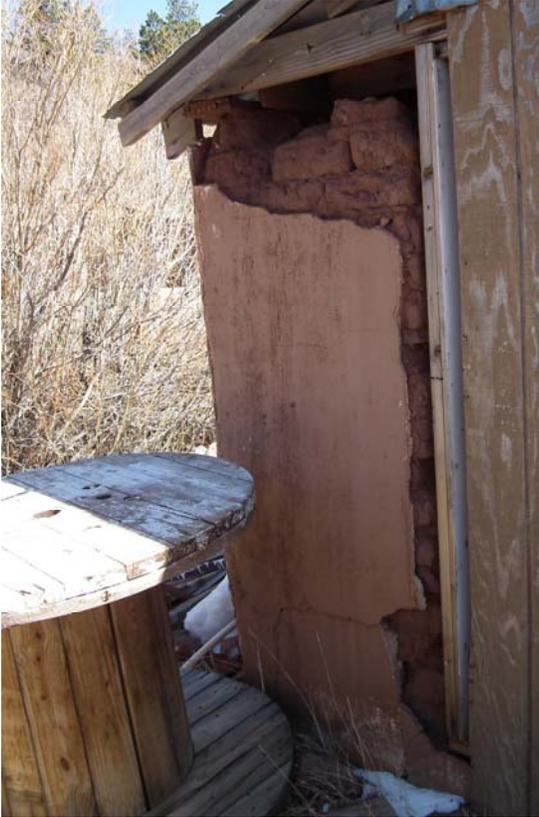
ML20 ADOBE CONDITION AT NORTHEAST CORNER

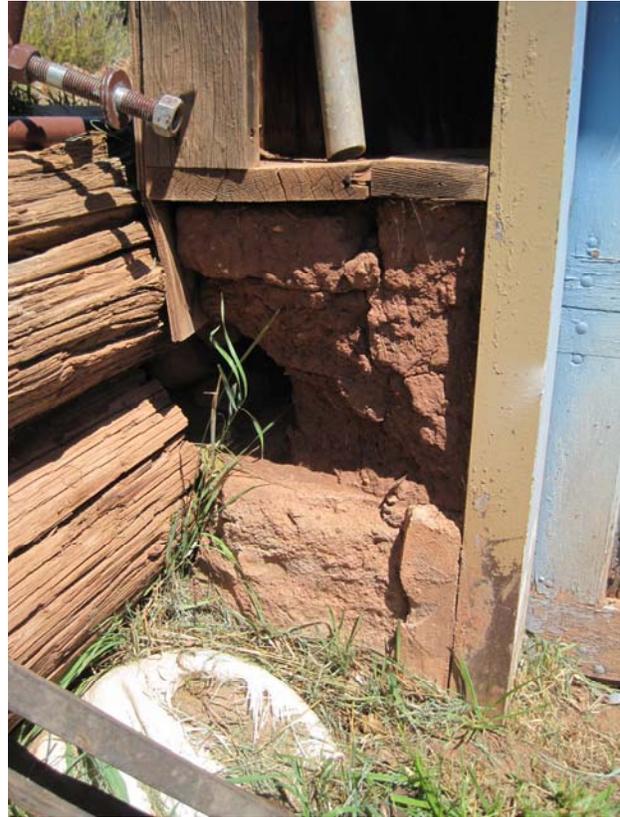
ML21 ADOBE CONDITION AT LOWER NORTHWEST CORNER ON WEST ELEVATION

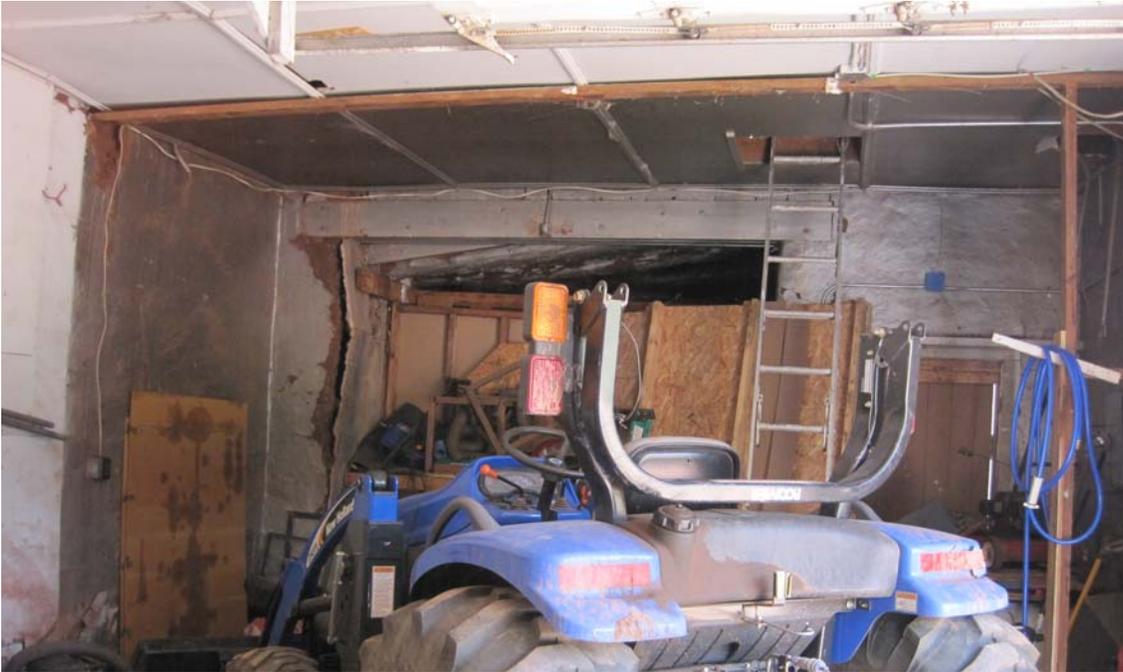
ML23 INTERIOR VIEW SHOWING SOUTH WALL OF ADOBE PORTION OF BUILDING – NOTE STUCCO PARGING DELAMINATION AT CHIMNEY AT LEFT CENTER OF PHOTO

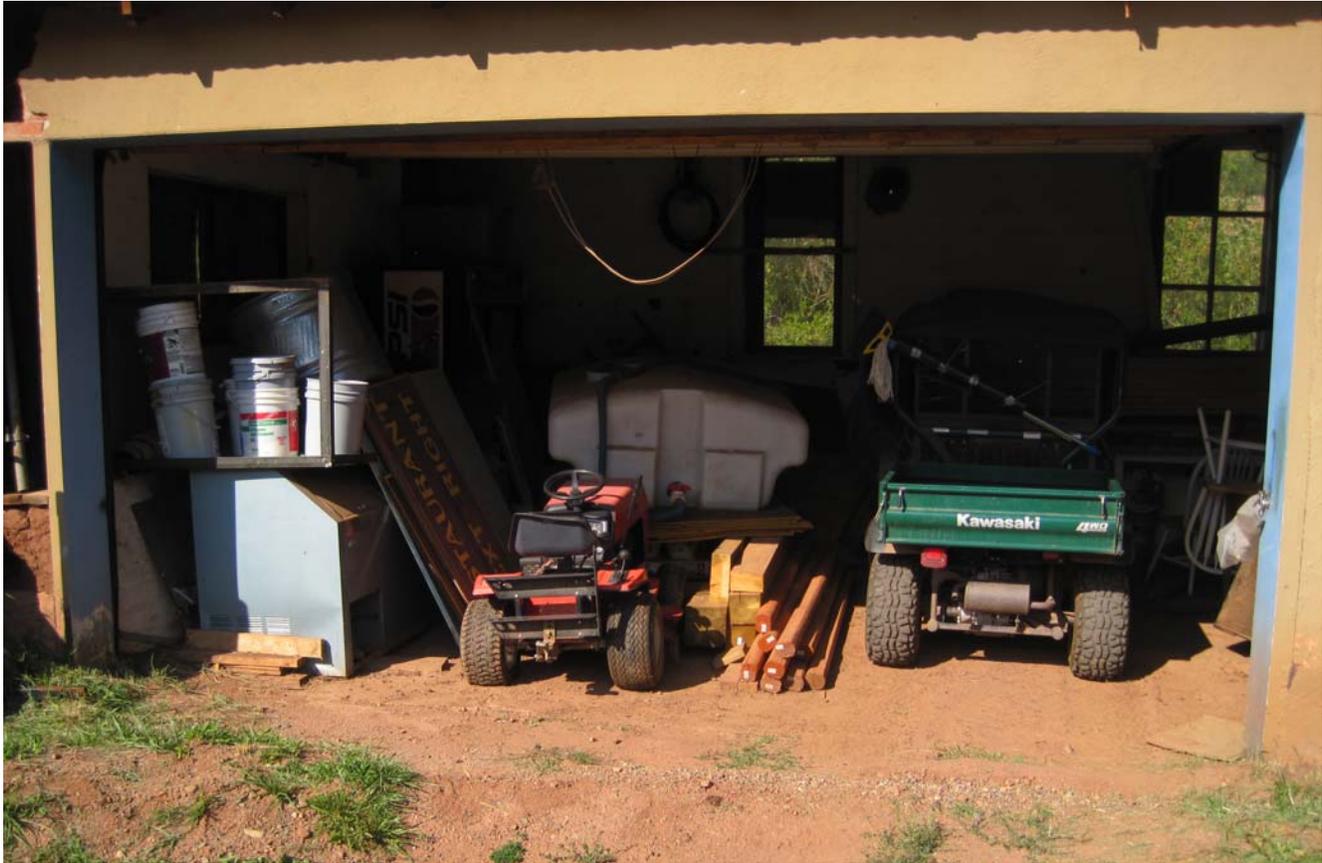
ML28 NORTHWEST LOCATION AT OVERHEAD DOOR WHERE HIGHER EXTERIOR GRADE DIVERTS WATER (AND SILT) INTO THE BUILDING

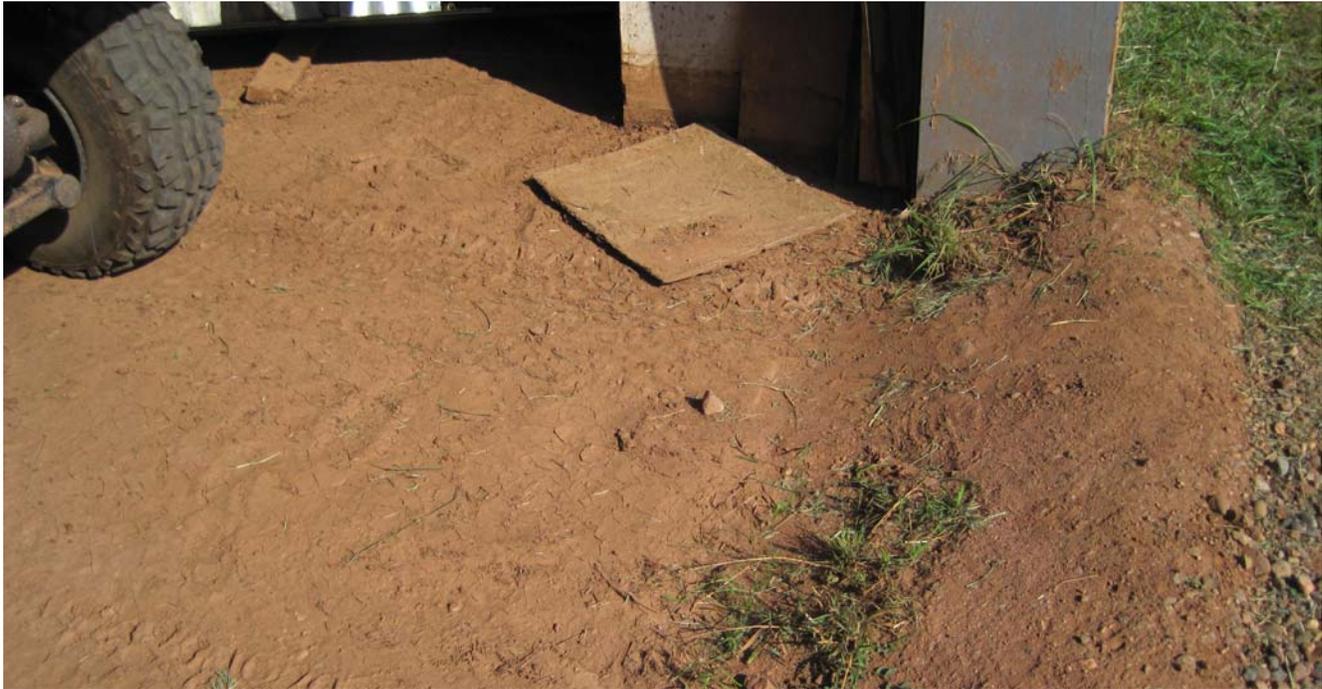
ML29 ALTERNATE VIEW SHOWING NEGATIVE DRAINAGE SLOPE

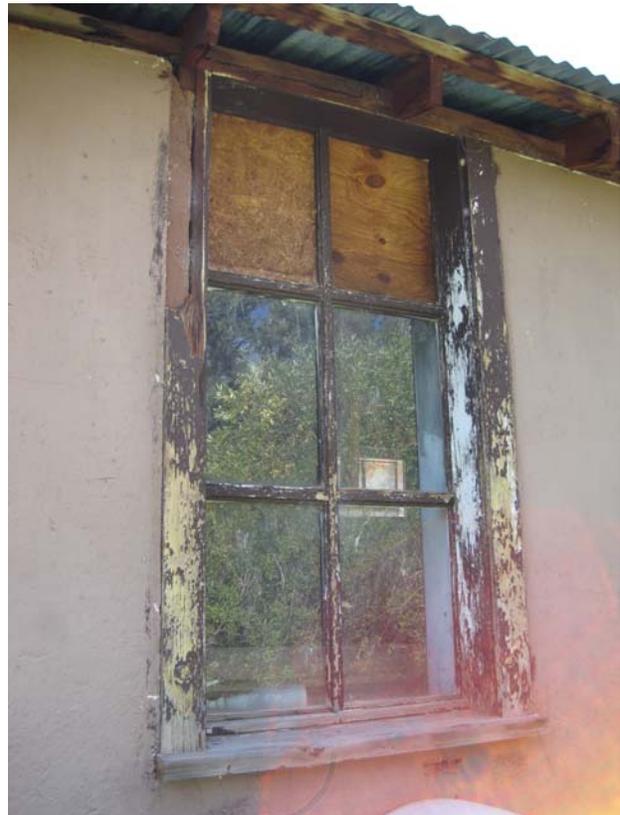
ML34 WINDOW ON EAST ELEVATION OF ADOBE STRUCTURE (CONDITION MORE TYPICAL)
