**Archaeological Assessment
Of the Monument Lake Fish Hatchery and Zoo (5LA.12777)
Las Animas County, Colorado**

**Anthony & Associates, Inc.
P.O. Box 271400
Fort Collins, Colorado 80527**

October 8, 2012

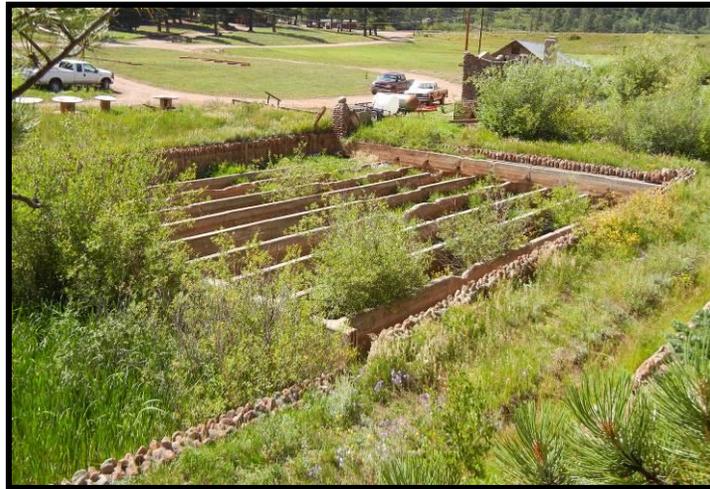
Figure 10. Feature 13, fish hatchery raceway pond, view to the northwest.

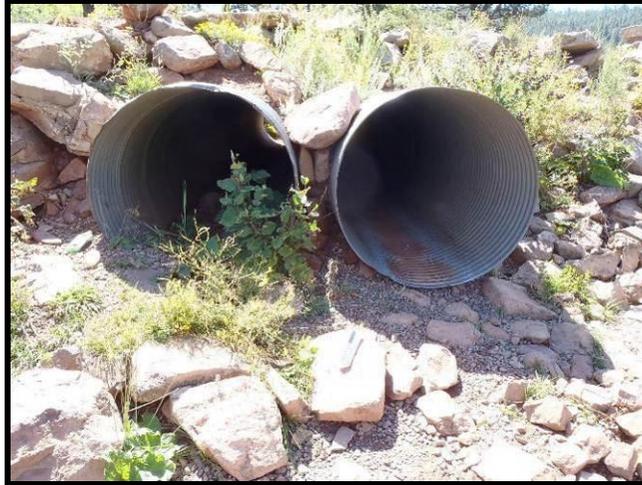
Feature 1 is a man-made spillway and canal used to control the depth of Monument Lake, located near the northeast corner of the survey area (see Figure B-1 in Appendix B). Two corrugated steel culverts allow overflow from the lake to travel under the lake perimeter road and enter a stone and Portland cement-walled canal approximately 307 feet long; this canal then intersects the central canal (Figures 19 and 20). The rock walls are constructed of uncut, untooled stones or cobbles and exhibit a pattern of construction that is typical for all of the stonework at the site in that the top course of stones are oriented vertically. Near the culverts, the walls have nine courses of stones and are approximately 5 feet 5 inches in height (Figure 21). The walls are 12 inches thick at the top but widen at the base, making the bottom of the canal approximately 4 feet wide, while the top of the canal is approximately 9 feet wide (viewed in profile). The west wall transitions from nine course to six courses at 10 feet from the culverts, and then to four courses 50 feet from the culverts. The west wall retains the four-course construction to the intersection with the central canal (Figure 22). The bottom of the canal is constructed of poured concrete with a veneer of cobbles. Minor damage was noted on both walls, and the bottom of the canal has been significantly damaged by the vegetation/root growth.

Figure 19. Lakeside culvert openings, view to the south.

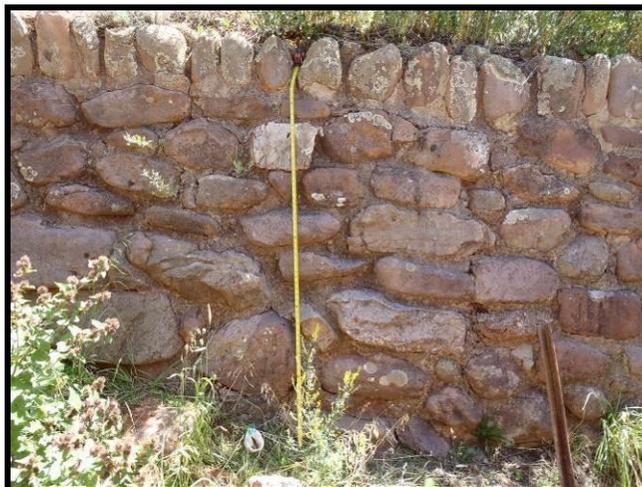
Figure 21. East wall near the culvert, 9-course height. View to the east.

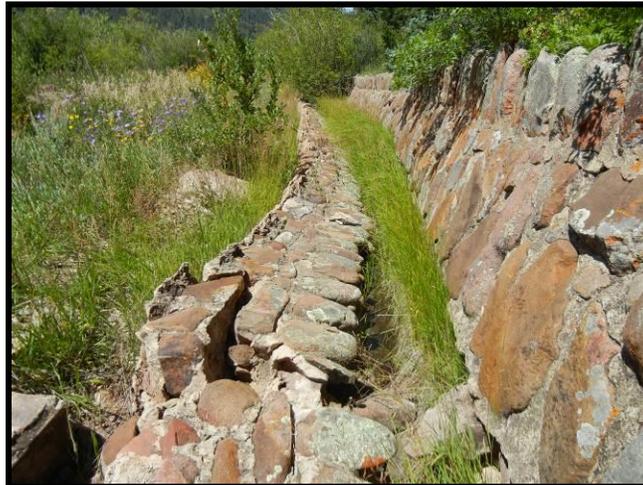
While in relatively good condition at the north half, the south portion of the central canal has some damage. The west wall of the canal has collapsed just south of the south pedestrian bridge to the zoo viewing area (Figure 34). This section is also the west wall of the zoo pond. Just south of the zoo pond gate, the west wall of the canal has toppled (Figure 35). It remains essentially intact, but has fallen over into the canal bed. This damage extends for approximately 100 feet. At the termination of the canal, water from the canal would have traveled through an informal drainage system to the Cherry Creek at the south end of the site.

Figure 35. Topped central canal, west wall, south of the zoo pond. View to the northwest.

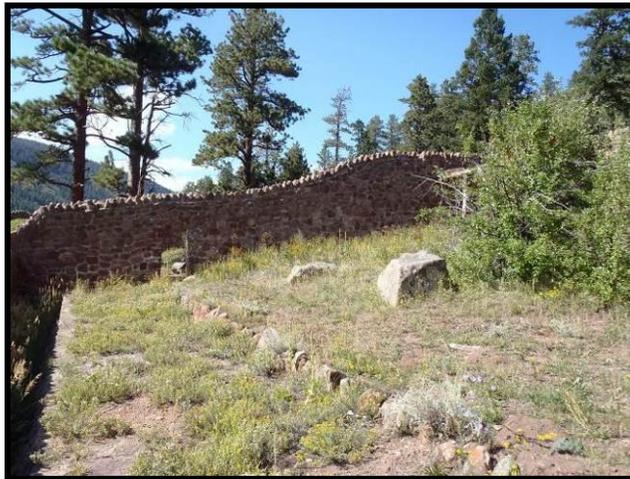
Figure 40. View of the shared wall between the northern and southern animal enclosures, view to the north from the southern animal enclosure.

The walls of the zoo enclosures appear to be in relatively good condition with no areas of significant damage. A few stones have come loose from the last, vertical course of stones on the southern wall, and there are some cracks in the Portland cement mortar, but no large failures. The iron gate between the enclosures is missing, as are the doors to the bear dens.

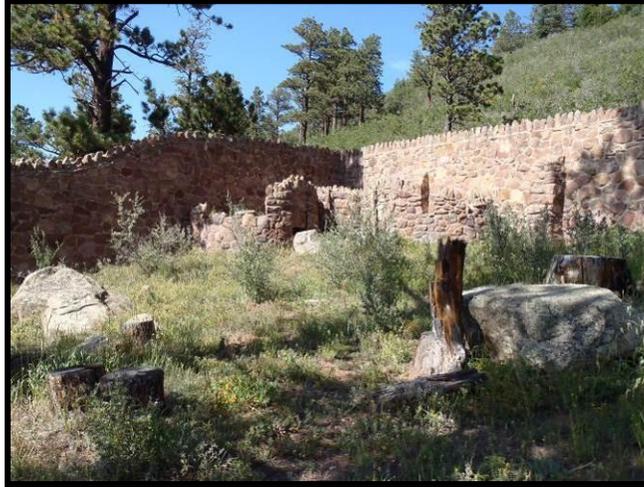
Figure 42. View of the northern animal enclosure bear dens. View to the north.

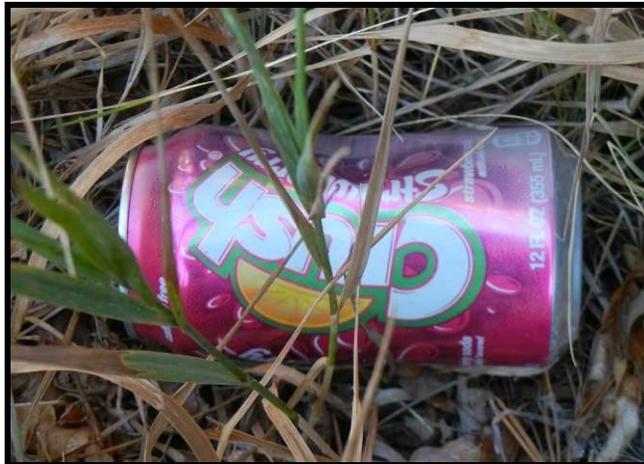
A few artifacts were found within the zoo enclosures. They included two Strawberry Crush soda cans, two embossed clear glass beverage bottle fragments with an applied color label, several fragments of green and brown bottle glass, and a clear Corona beer bottle. With the exception of the embossed glass fragments (Figures 43 and 44), it would appear that the majority of artifacts are of relatively recent origin (Figure 45).

Figure 45. Modern soda can, southern enclosure.

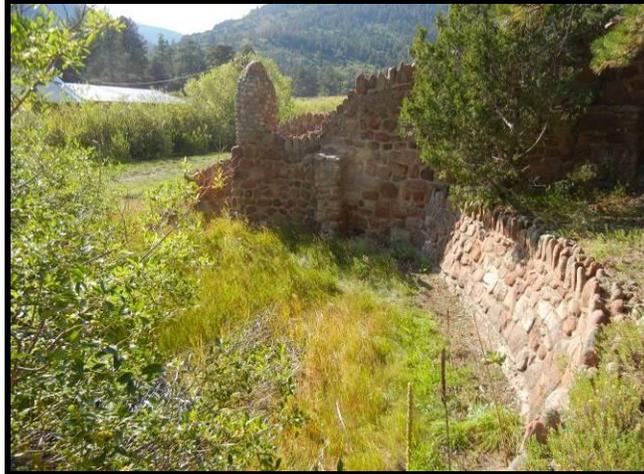
Feature 8 is an ovular pond structure located south of the zoo enclosures. The pond measures 80 feet (north-south) by 34 feet (east-west). The southern wall of the zoo enclosure forms the north wall of the pond. The east wall of the zoo pond, which is cut into the hillside, is curved (Figure 46) while the west wall of the pond is straight and a continuation of the central canal wall. The walls are approximately 5 feet tall on the east side of the pond and 3 feet tall on the west side; they are constructed of stones and Portland cement in the same manner as the other features associated with the site. The walls have 12-inch concrete footers and bases that flare out towards the pond interior. The central canal (Feature 4) empties into the zoo pond at the north end. There is a gated opening on the southern end of the pond to return water to the southern section of Feature 4. There is a 12-inch diameter subterranean pipe running from the southeast corner of the pond to the northeast corner of the raceway (Figure 47). Twelve feet of the west wall has collapsed at the north end (Figure 48). The east wall appears to be in good condition. The interior of the pond has heavy vegetation overgrowth.

Figure 46. Feature 8 overview. View to the northwest.

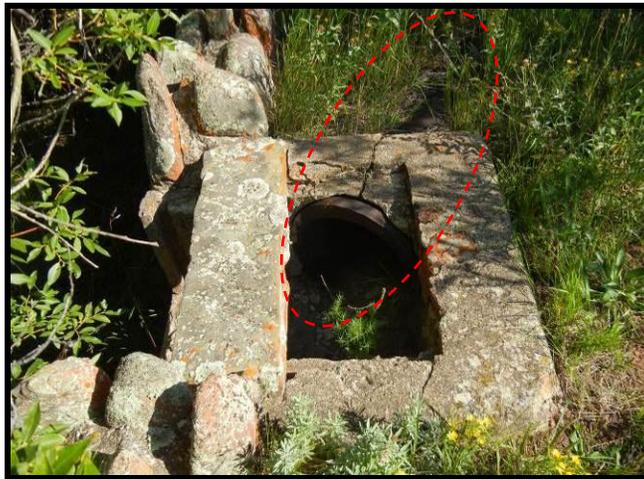
Figure 47. Large diameter pipe running from the zoo pond to the fish hatchery raceway. View to the southeast.

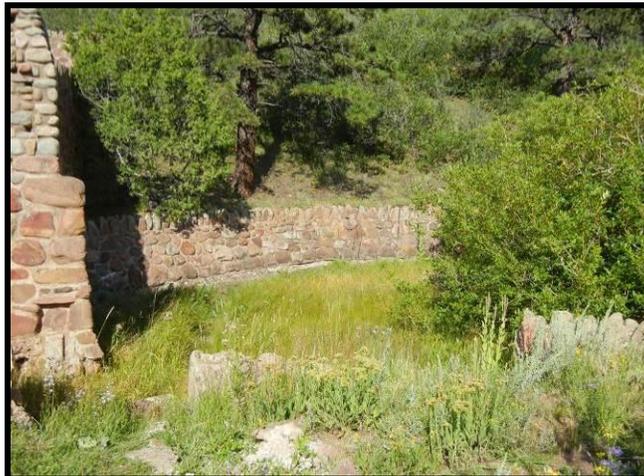
Figure 48. Collapsed portion of the west zoo pond wall (also the west wall of the central canal). View to the east.

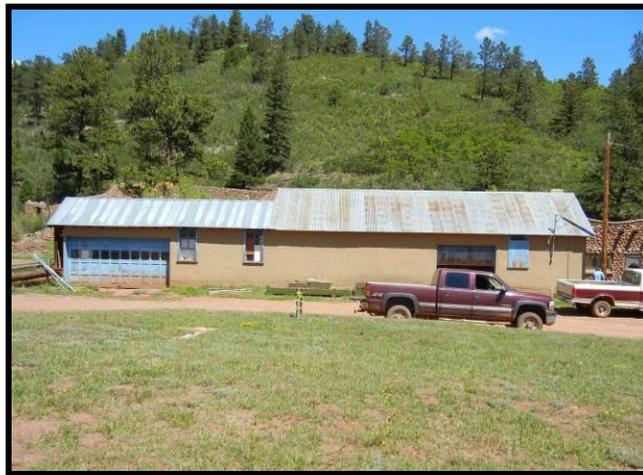
The building measures 80 feet by 18 feet 2 inches, and is oriented on an approximate northwest-southeast axis (Figure 49). It is primarily constructed of adobe, although alterations to the structure show a metal I-beam and brick infill above the north garage door (Figure 50). The stucco may be patched with incompatible materials in some locations. The roofing material is corrugated metal sheeting; the roof line changes in one location (see Figure 49, also see B-7 in Appendix B for a plan view). The building has two garage doors on the west elevation and three windows. The north garage door is a double door; the south garage door is a single door. There are five windows on the east elevation and a chimney. The windows are six-lite, single-pane wood windows. There is a door on the south elevation; the north elevation has been altered and the original configuration of any windows, if extant, is unknown (Figure 51).

Figure 49. The west elevation of Feature 9. View to the east.

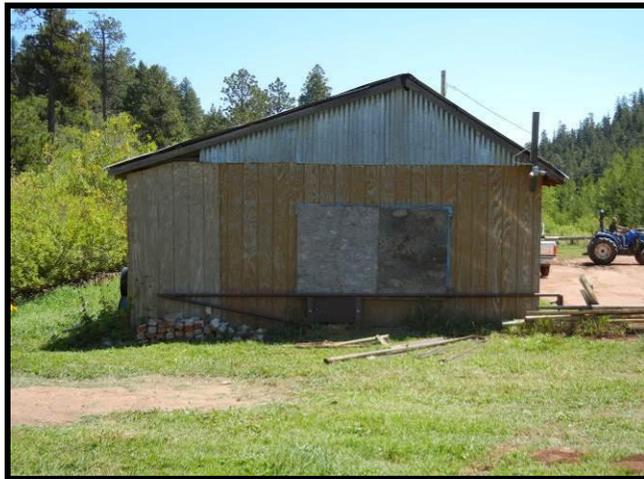
Figure 51. North elevation of the fish hatchery garage, showing alterations. View to the southeast.

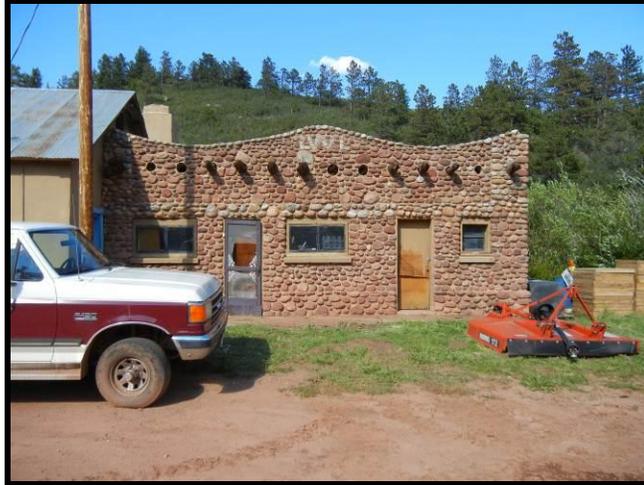
Feature 10 is a single-story, stone masonry building attached to the fish hatchery garage on the north elevation (Figure 52). It has a rectangular footprint and is oriented on an approximate northwest-southeast axis (Figure B-7 in Appendix B). It is constructed of untooled and uncut stone with Portland cement mortar. The roof is a shed roof that slopes down to the east with parapet walls on the west and south elevations (Figures 53 and 54). The roof is covered with a sheet membrane. There are wood vigas that penetrate the masonry walls. These vigas date to the original construction. The parapet on the west elevation has a decorative finish and “IWL” inlaid in cut quartz cobble above the central window. There are concrete window sills and door thresholds with wood trim. The original windows have been removed. The east elevation of this building forms the west wall of the fish hatchery building pond, Feature 12.

Figure 52. West elevation showing wood vigas and inlaid quartz. View to the east.

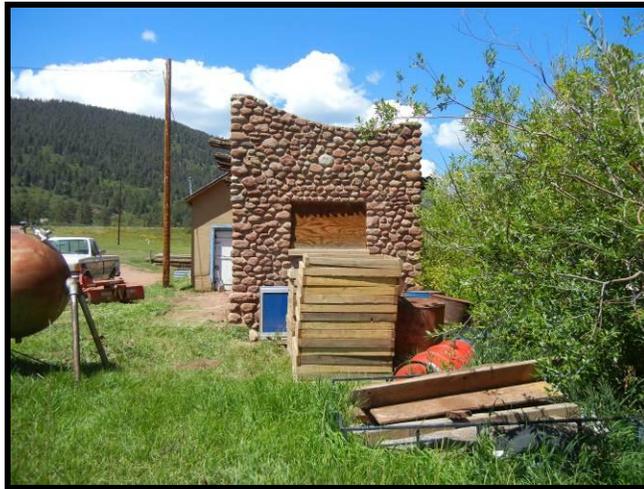
Figure 53. South elevation of the fish hatchery building. View to the north.

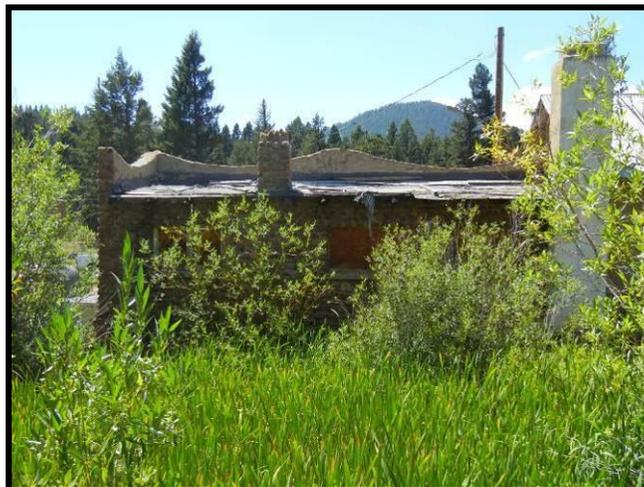
Figure 54. East elevation of the fish hatchery building. View to the west.

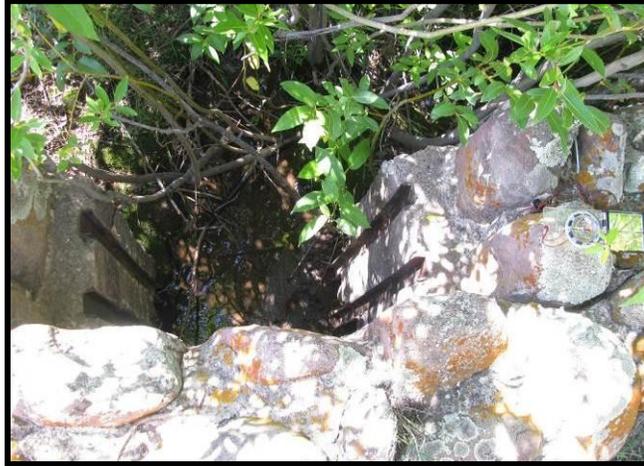
Figure 56. Southeast corner of fish hatchery building pond showing gated subterranean channel to the central canal.

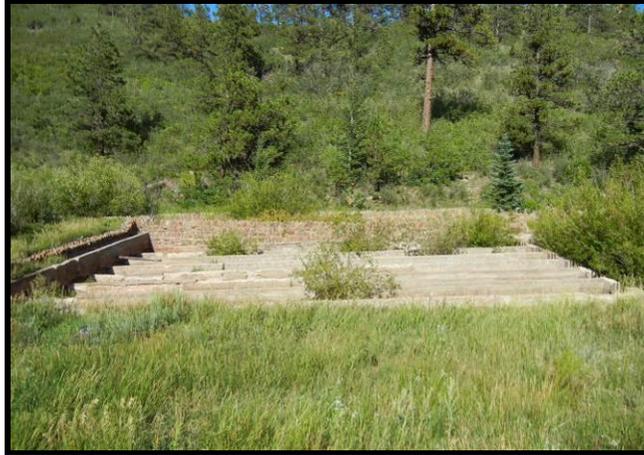
Feature 13 is a sunken, rectangular raceway pond measuring 60 feet by 65 feet and oriented on a northwest-southeast axis. The interior height of the perimeter walls is approximately 5 feet. Ten raceway channels measuring 5 feet in width run parallel to the long axis (Figure 58 and Figure B-9 in Appendix B). The exterior walls of the raceway pond are constructed of untooled stones and Portland cement; the east wall is comprised entirely of stones with cement mortar, while the west wall is constructed of board-formed cement with a cap of vertically oriented stones. The north wall has an interior wall of poured concrete forming a channel for water supplied by a large diameter pipe entering the raceway at the northeast corner. The pipe runs north to the central canal (Figure 59). Each raceway has a gated opening for the inflow of water from the north wall channel. The gated openings led to 5-inch diameter pipes that extended 8 feet from the north wall; most of these pipes are missing. Two pipes remain in-situ; of those, one is broken. Two pipes lie in raceway beds (Figure 60).

Figure 58. Overview of the raceway pond, view to the east.

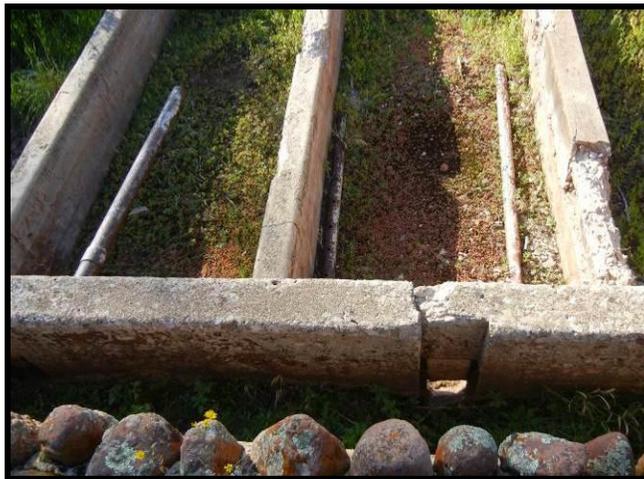
Figure 60. In-situ and displaced small-diameter outlet pipes in the raceways. View to the southeast.

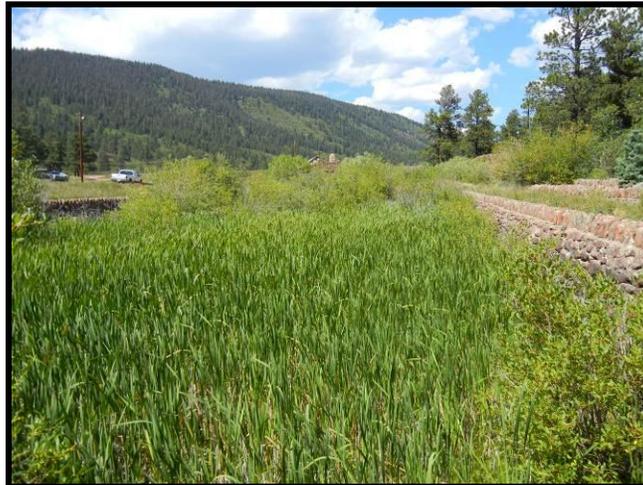
Feature 14 is a large rectangular retaining pond located to the south of the raceway pond. It measures approximately 60 feet wide at the north end, and extends some 165 feet to the south (Figure 63 and Figure B-10 in Appendix B). The south end of the retaining pond is approximately 89 feet wide and has two outlet channels that allow water to drain to Cherry Creek. The primary outlet channel has a raised concrete bridge with elaborate stonework detailing (Figure 64). The smaller outlet channel is made of poured concrete and extends to the south from the southwest corner of the pond (Figure 65). The walls of the retaining pond are constructed of untooled, uncut stone and Portland cement. The depth of the pond is approximately 8 feet. The walls flare towards the interior and have supplemental stone buttresses approximately every 25 feet on the east and west walls. The walls project above ground level on the east side approximately 14 inches; on the west side, the wall does not project above the ground line (Figure 66). The interior of the pond is crossed near the north end by a low-lying poured concrete wall. This wall had water control gates in it at one time but is fragmented and in very poor condition (Figure 67). The pond is full of cattails and willows, but the exterior walls appear to be in relatively good condition. Damage tends to be limited to erosion or scouring of the Portland cement mortar. The pond has some standing water; a small stream of water also flows through the main outlet channel.

Figure 63. Retaining pond, overview. View to the northwest.

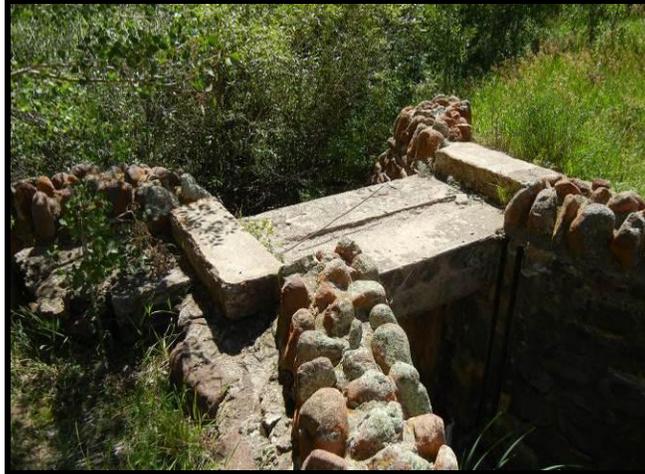
Figure 64. Main water outlet on the south end of the retaining pond. View to the south.

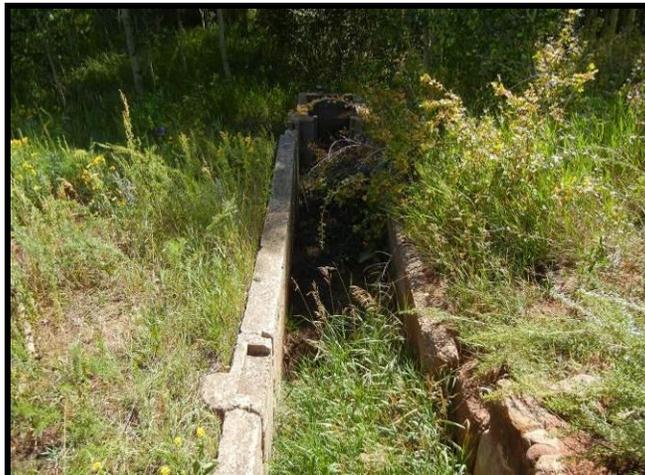
Figure 65. Outlet channel at the southwest corner of the retaining pond. View to the southeast.

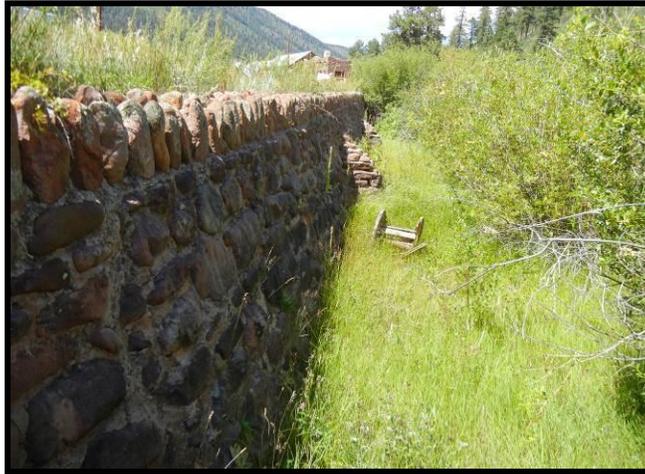
Figure 66. The west wall of the retaining pond showing the ground level at or near the same height as the wall. View to the north.

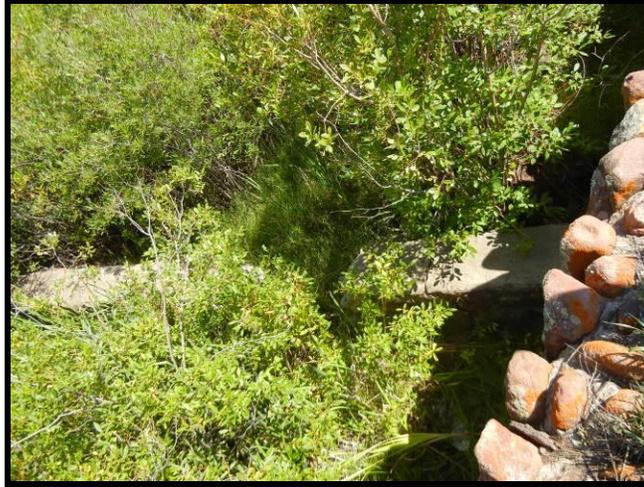
Figure 67. Concrete wall with water control gates inside the large retaining pond. View to the southeast.

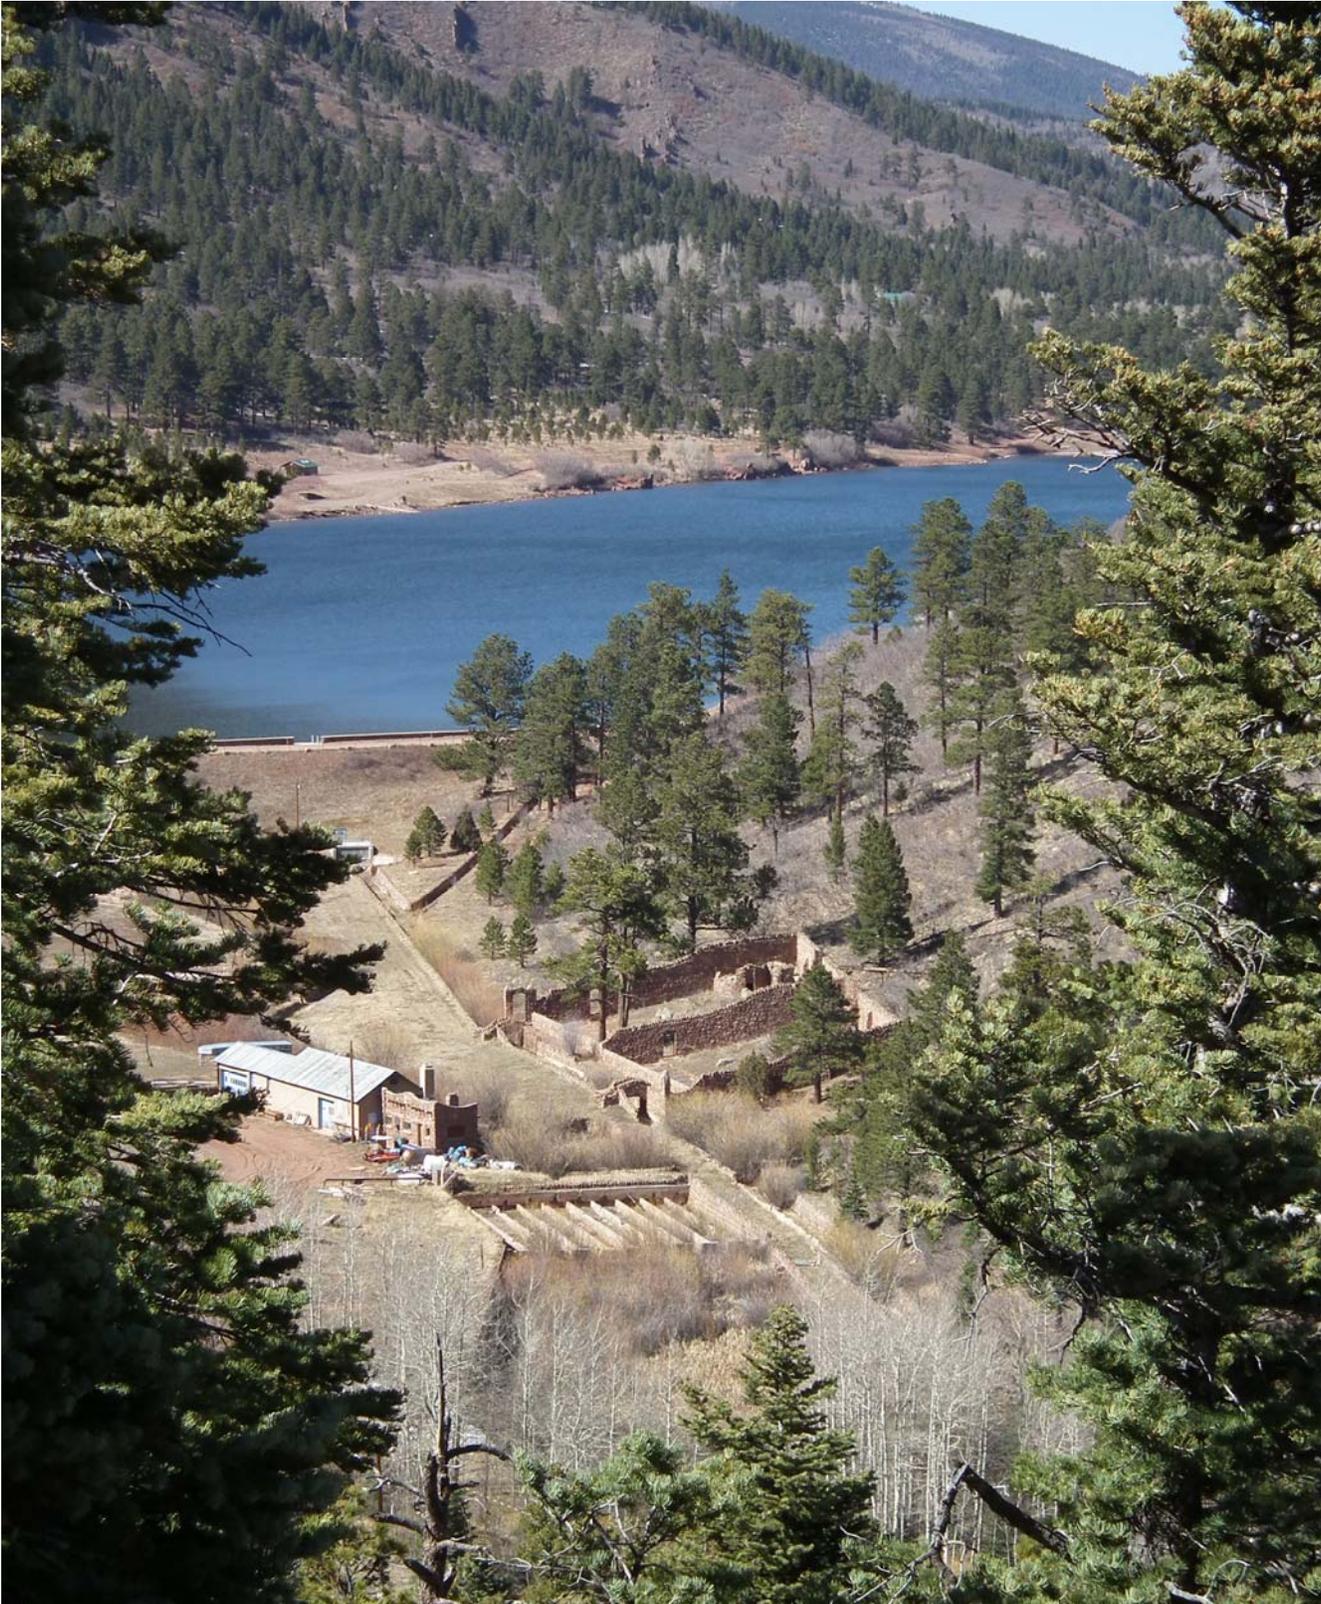
ML01 MONUMENT LAKE FISH HATCHERY BUILDING, INCLUDING SITE CONTEXT, AS VIEWED FROM HILLSIDE TO THE SOUTH, CAMERA FACING GENERALLY NORTH

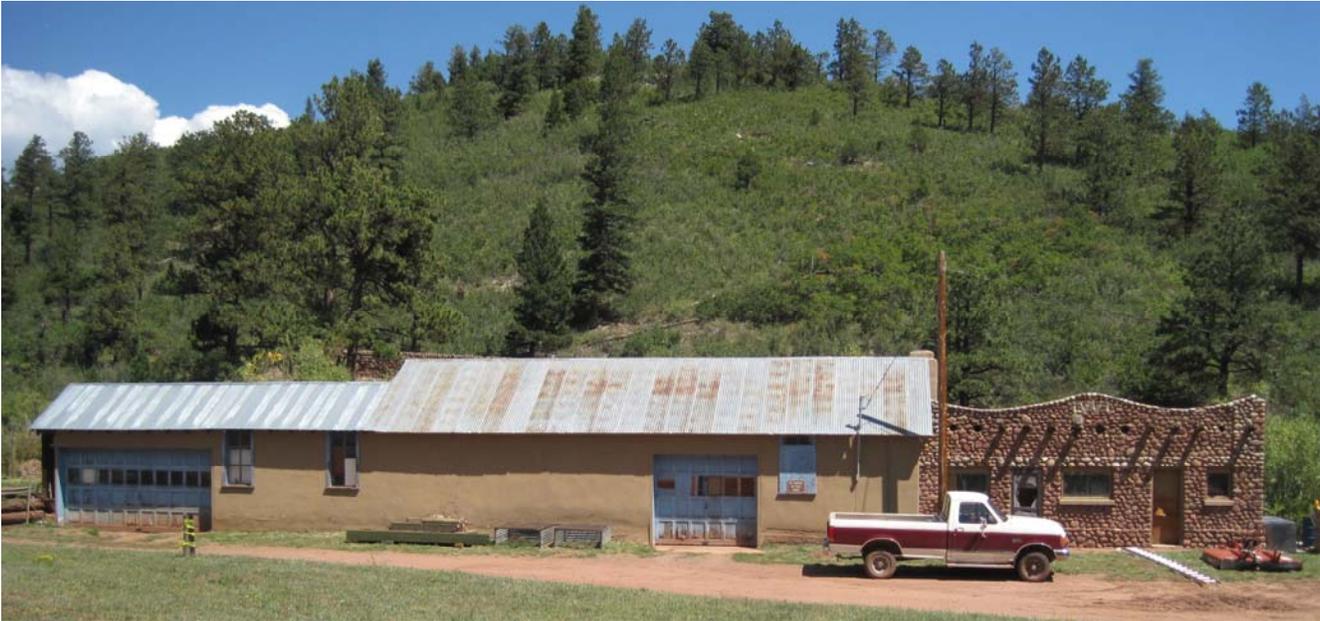
ML02 FISH HATCHERY BUILDING, WEST (FRONT) ELEVATION

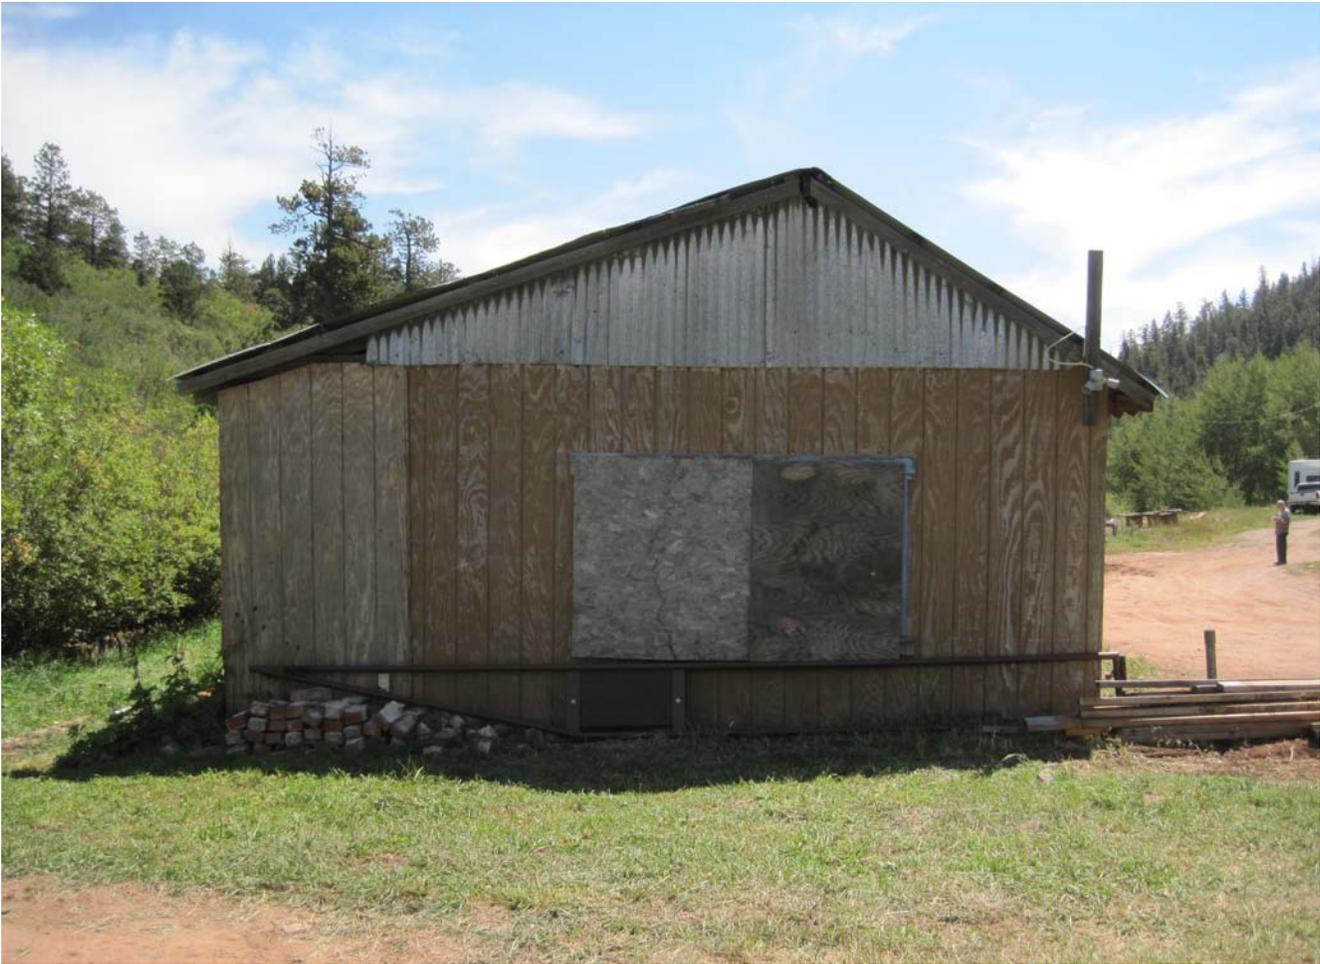
ML03 FISH HATCHERY BUILDING, NORTH ELEVATION

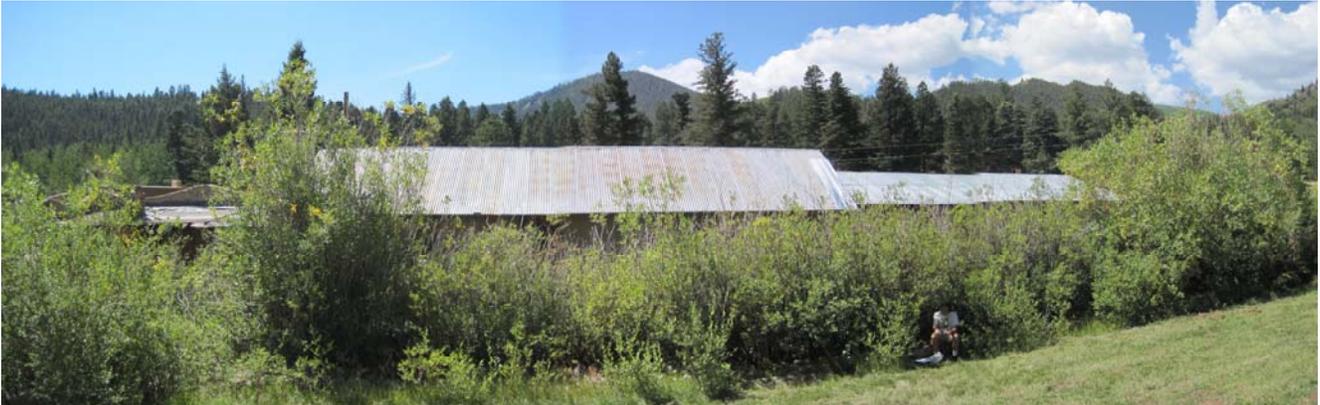
ML04 FISH HATCHERY BUILDING, EAST (REAR) ELEVATION

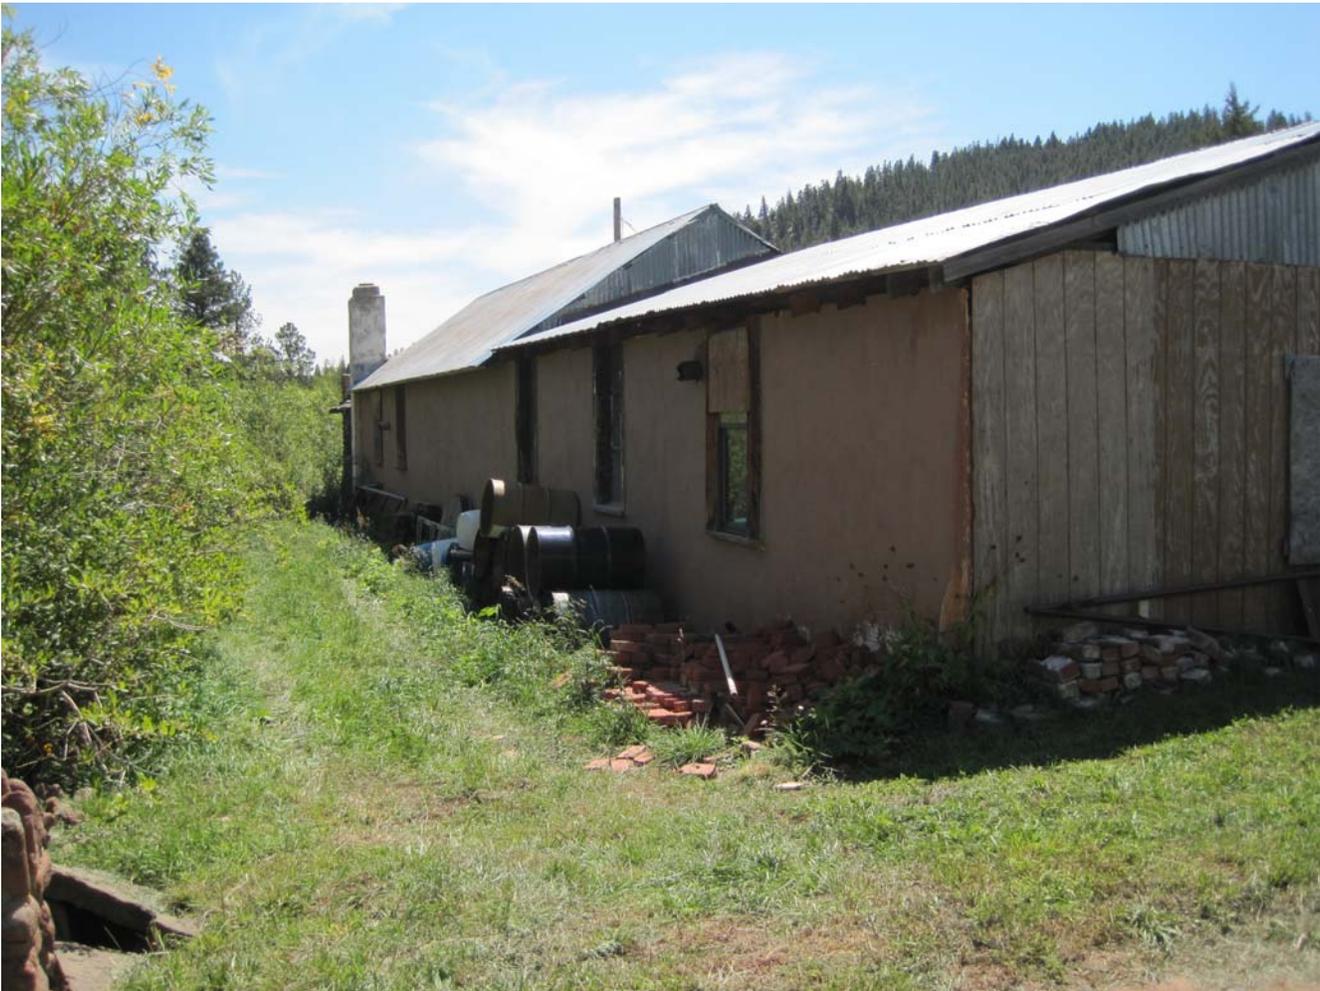
ML05 FISH HATCHERY BUILDING, OBLIQUE OF EAST (REAR) ELEVATION AT LEFT AND NORTH ELEVATION AT RIGHT

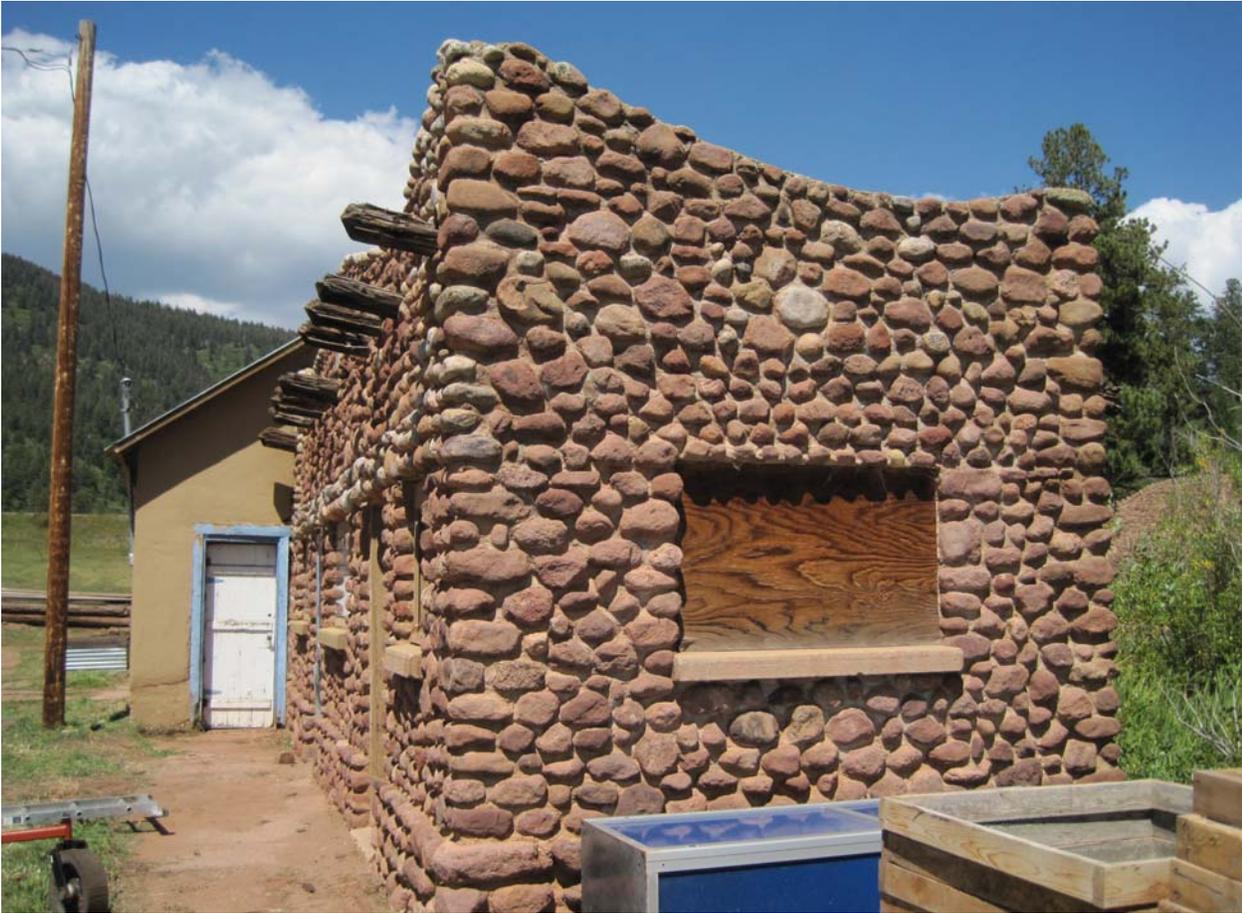
ML06 FISH HATCHERY BUILDING, SOUTH ELEVATION

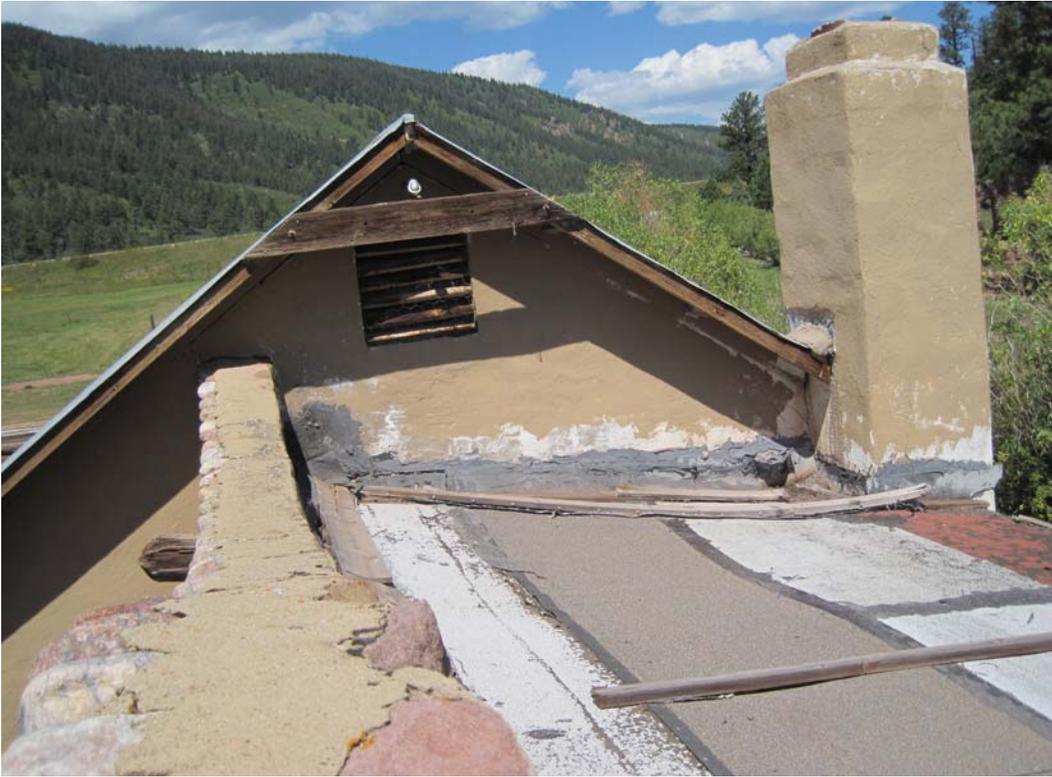
ML08 NORTH END OF ROOF ON STONE SECTION, PARAPET, AND SOUTH END OF ADOBE SECTION

The stone masonry requires replacing the missing parapet top stones and any other missing stones. If areas of missing or eroded mortar are discovered, they should be repointed with a matching mortar. The stucco parging atop and behind the parapet should be restored. A mortar analysis should be performed.

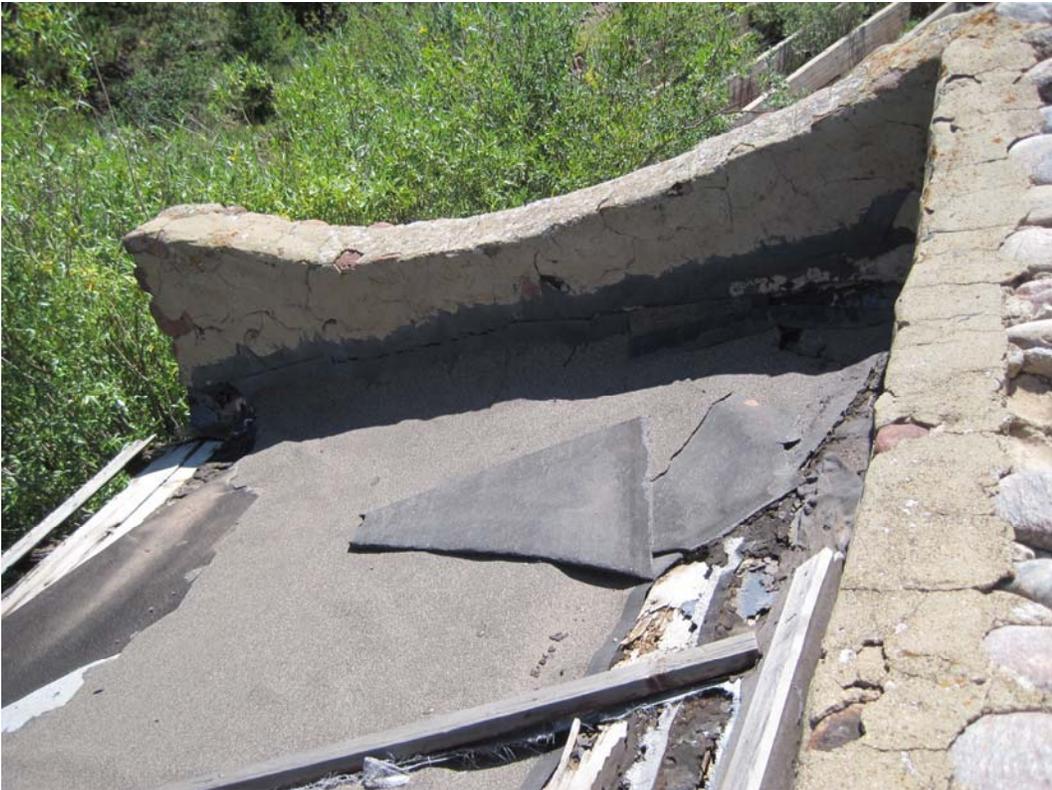
ML09 STONE SECTION PARAPETS AND SOUTH END OF ROOF

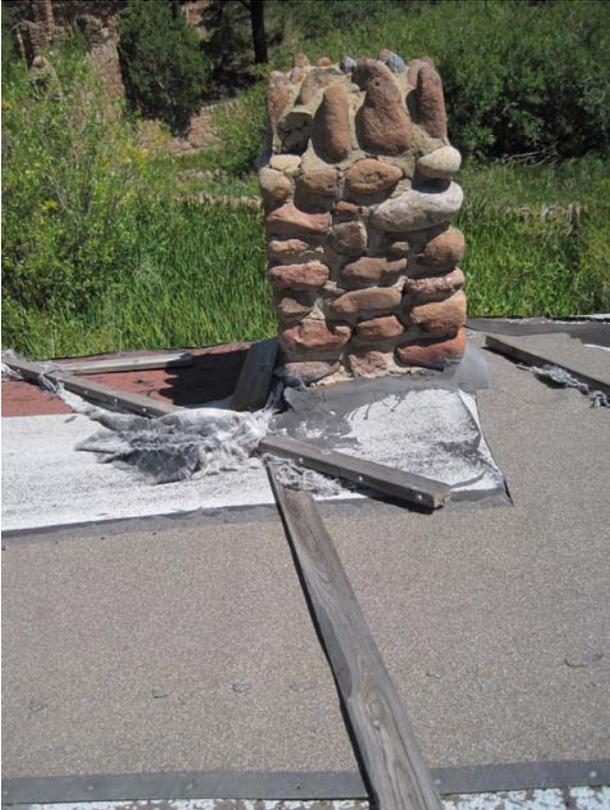
ML10 STONE CHIMNEY ON ROOF'S EAST EDGE

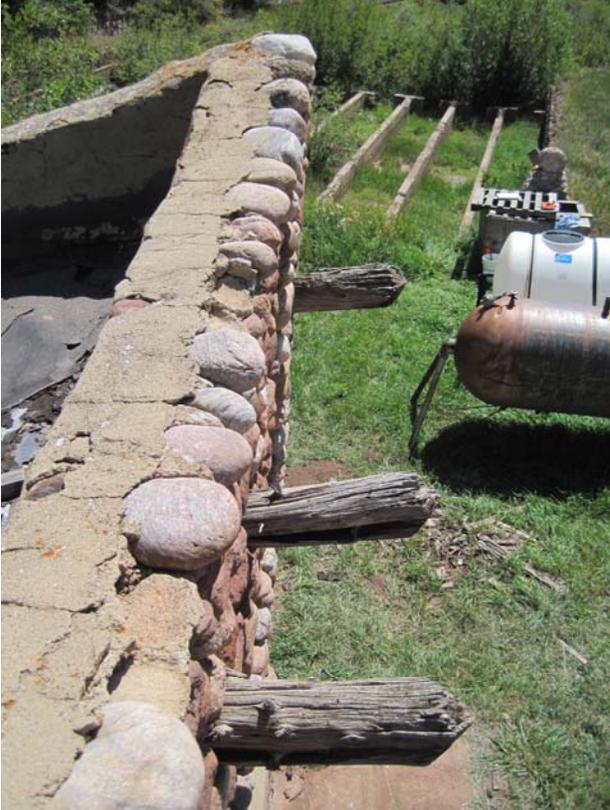
ML11 STONE PARAPETS AND VIGAS

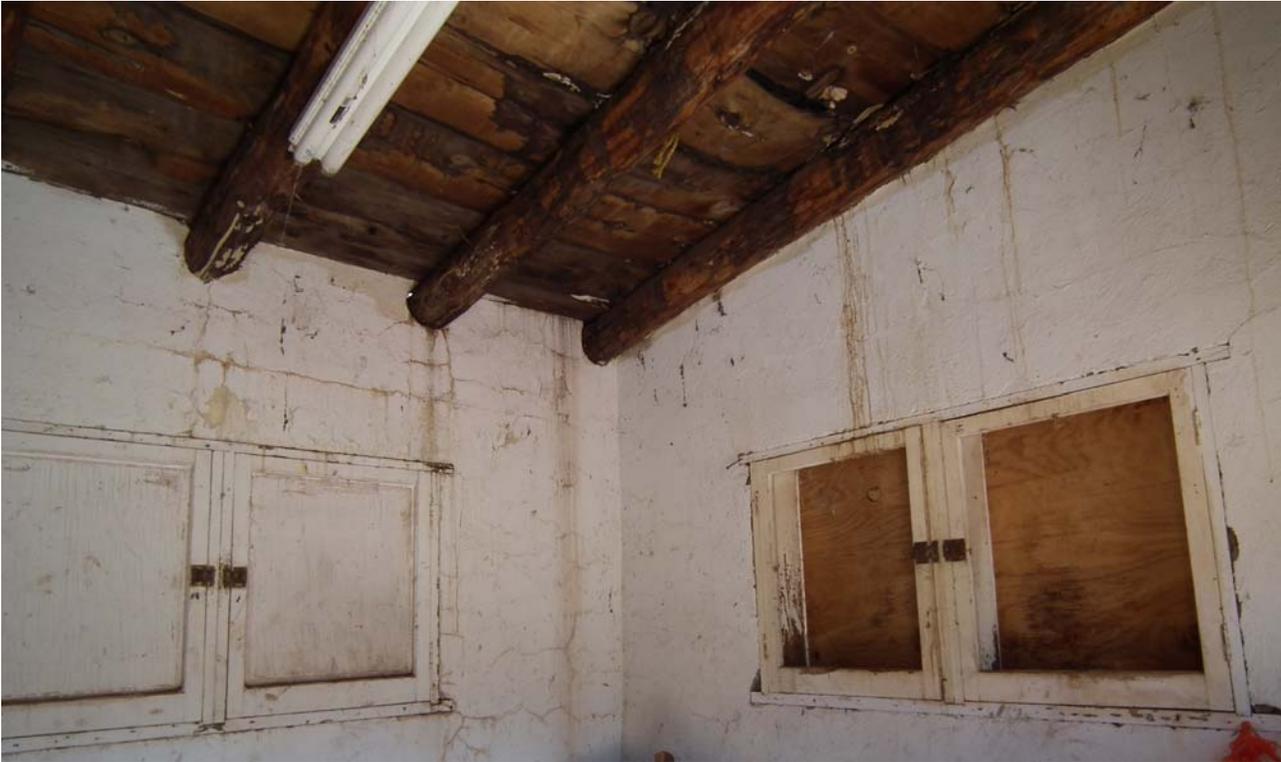
ML13 INTERIOR OF SOUTHEAST CORNER OF STONE SECTION OF BUILDING

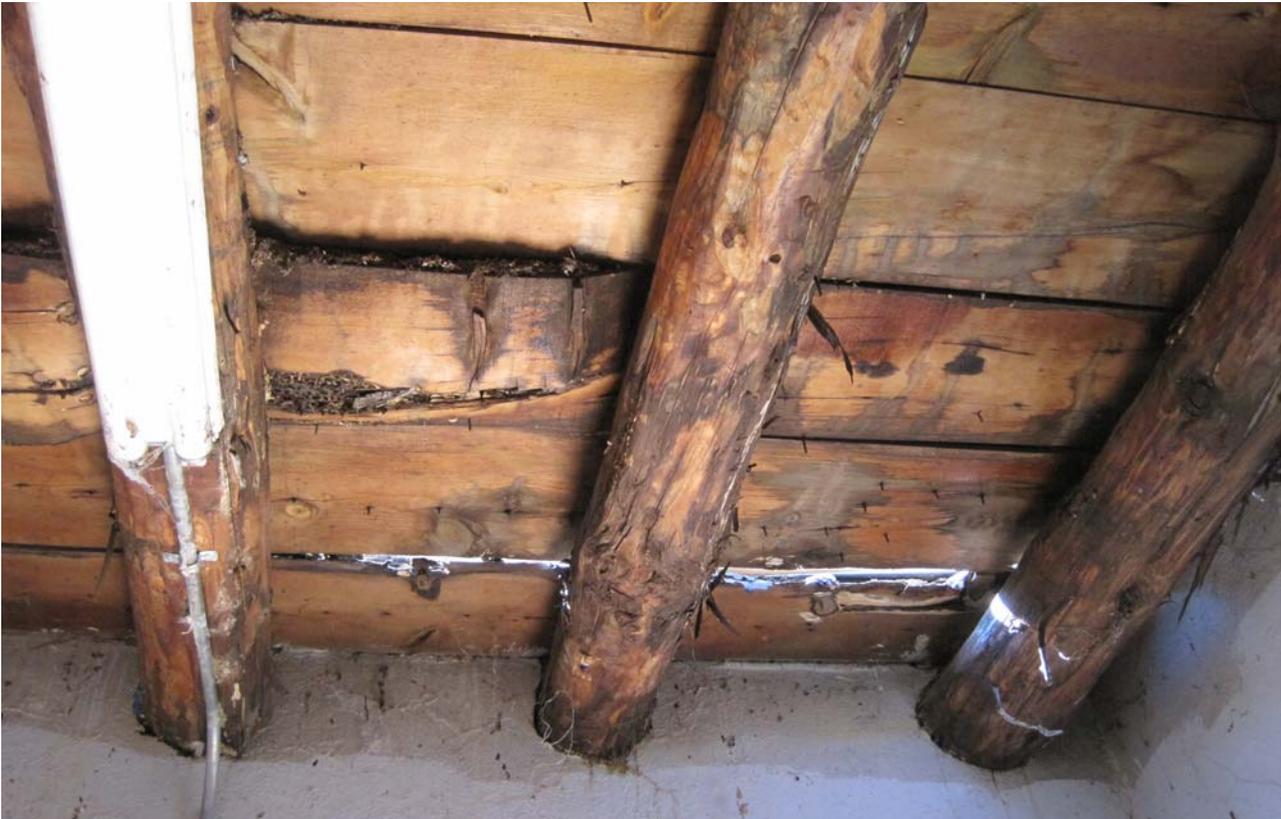
ML14 ORIGINAL VIGAS AND ROOF SHEATHING AT INTERIOR OF STONE SECTION OF BUILDING

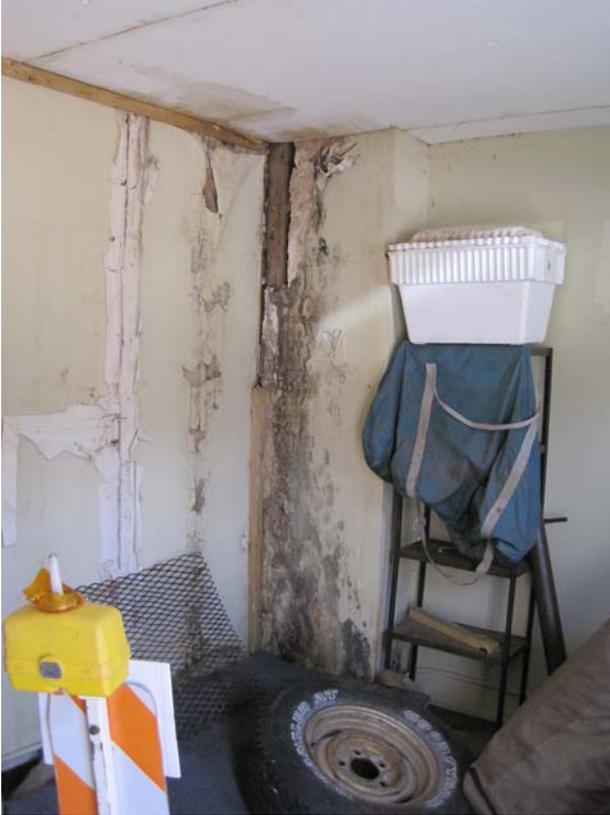
ML15 CHIMNEY AT NORTHEAST CORNER OF
STONE SECTION OF BUILDING
