**Archaeological Assessment
Of the Monument Lake Fish Hatchery and Zoo (5LA.12777)
Las Animas County, Colorado**

**Anthony & Associates, Inc.
P.O. Box 271400
Fort Collins, Colorado 80527**

October 8, 2012

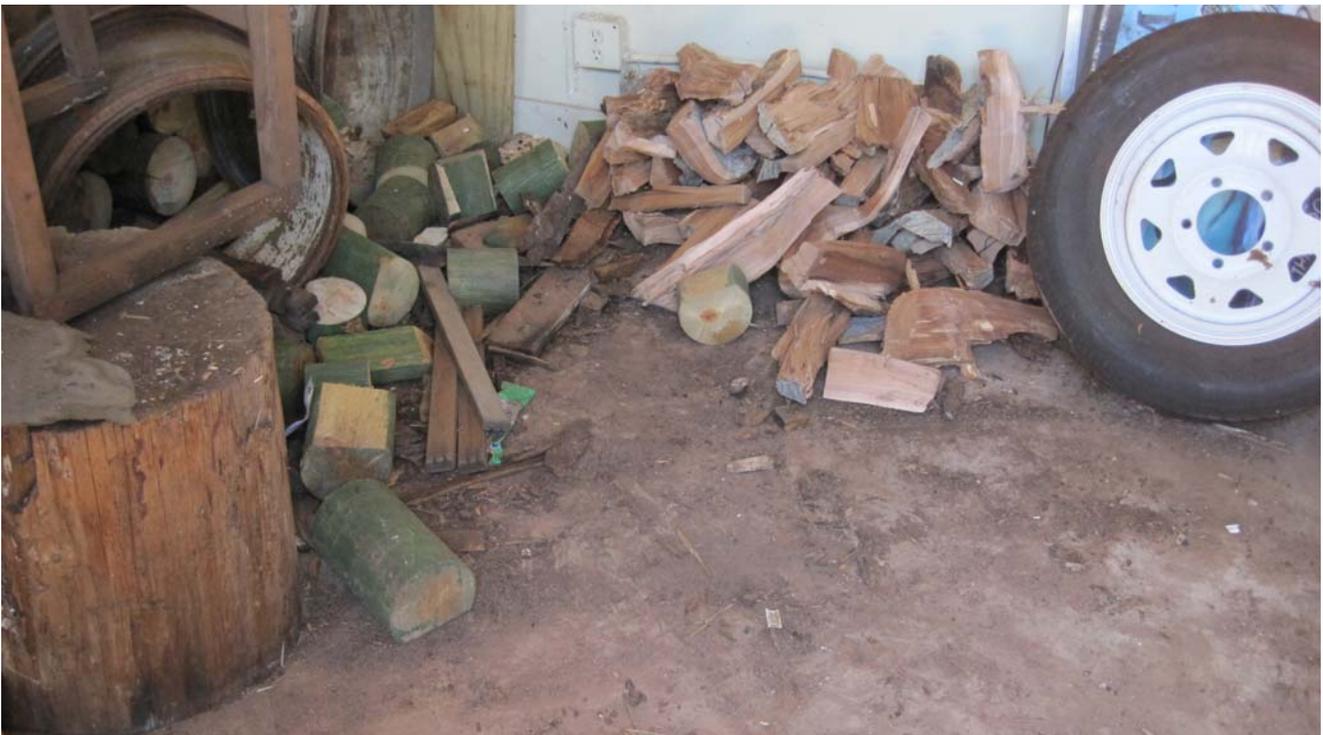
ML17 FLOOR IN STONE SECTION OF BUILDING

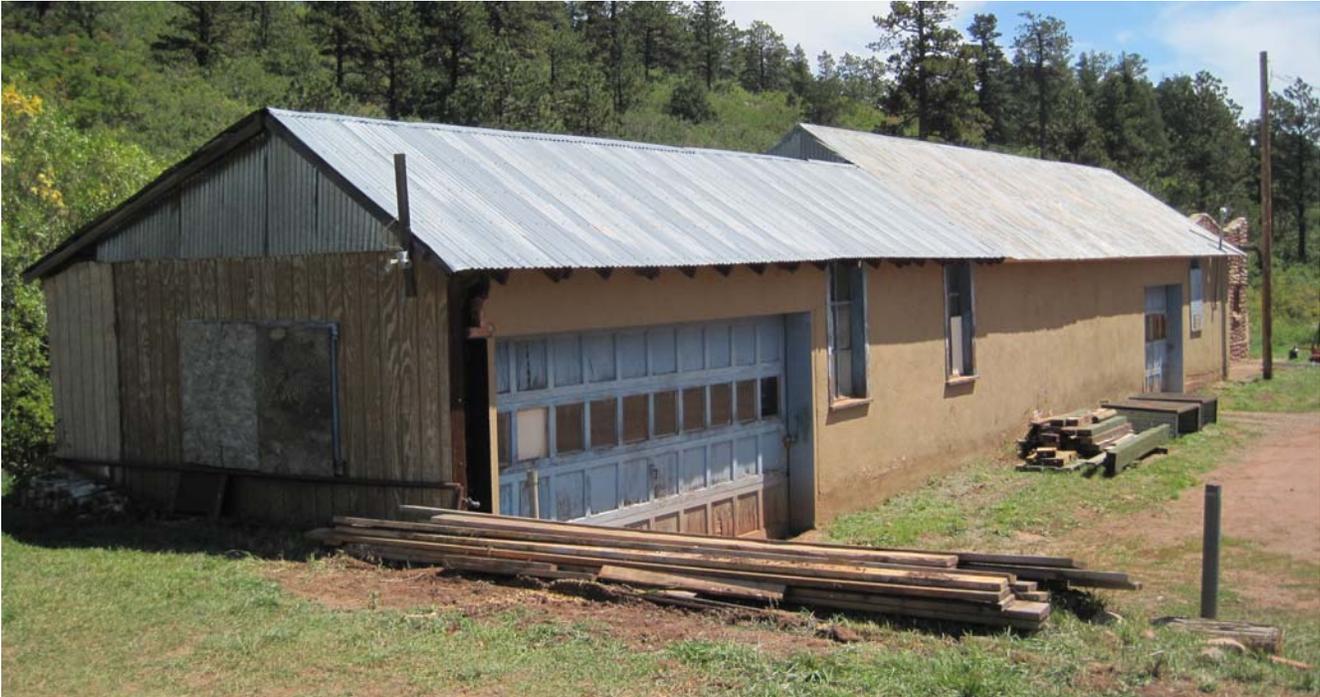
ML18 OBLIQUE VIEW OF ADOBE SECTIONS OF FISH HATCHERY BUILDING AND SITE CONTEXT

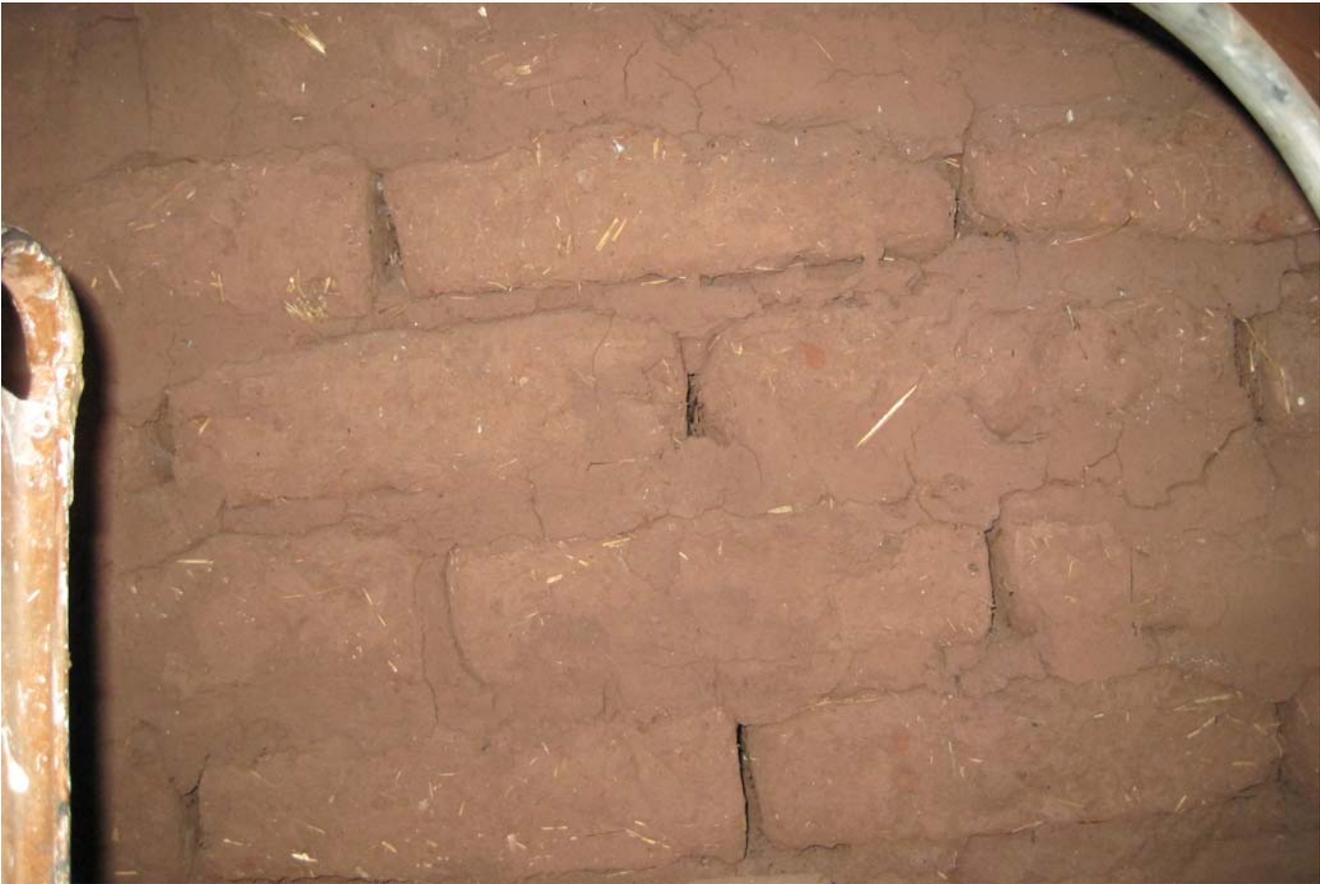
ML19 ADOBE BRICKS VISIBLE FROM ATTIC SPACE

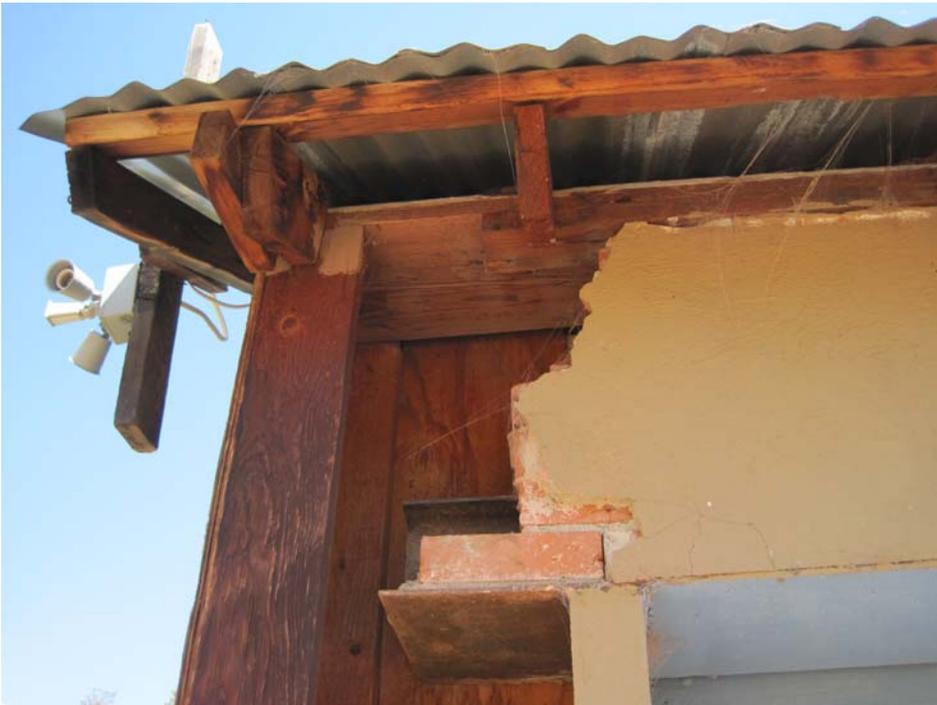
The center and northern sections of the building, now used for garage, shop, and storage purposes, have 12" thick adobe perimeter walls on concrete stem walls, the stem walls extending approximately 2' above grade, all on concrete foundations with concrete floors. The adobe is parged on the exterior with cementitious stucco in a buff color and on the interior up to ceiling height, mostly painted white. The ceiling joists are pocketed into the adobe, visible on the interior of the center section from the attic space, and while the adobe is concealed by wood blocking at the interior of the northern section, it is minutely visible, as is the wooden top plate, on the exterior where the historically present 1x blocking/trim between the rafter tails is missing. Also visible from the attic are the exposed interior faces of the adobe blocks of the south gable, measuring approximately 10" deep by 14" long by 4" high, and that dimension translates well as the general size of the adobe units for the walls protected by stucco. The mortar appears to be a mud mortar visually similar to the adobe blocks. The majority of the north adobe wall has failed and has been replaced with a wood framed wall, sided with unfinished T-111 siding panels on the exterior with corrugated galvanized steel above covering the gable end. The interior of this wall is sheathed with plywood, painted white. There are portions of adobe still existing at both ends, but the lower portion on the west elevation is no longer protected by stucco parging. A retaining wall fashioned of round timbers abuts the building at this location. Just south of this corner is a retrofitted double overhead door with a steel frame with stuccoed red brick above the lintel, the end portion of which is missing.

ML22 UPPER NORTHWEST CORNER SHOWING GARAGE DOOR FRAME, LINTEL, AND OTHER EXISTING CONDITIONS

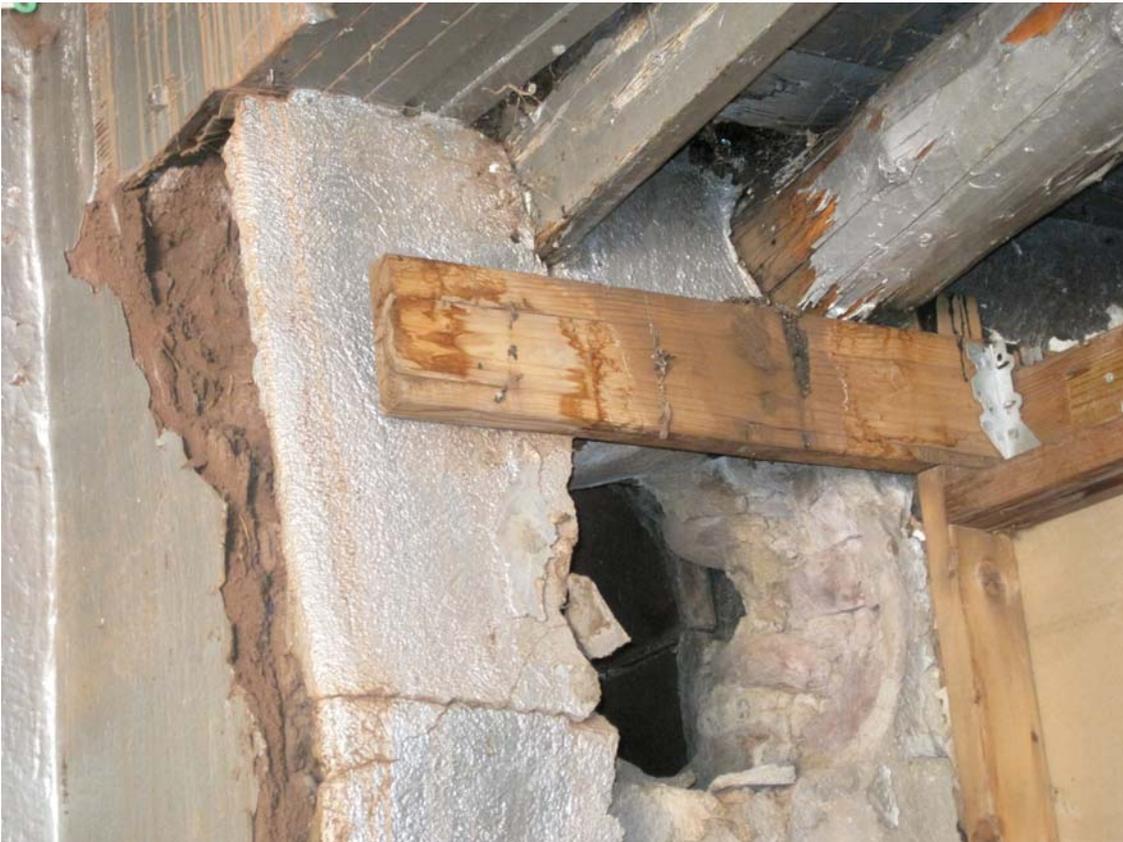
ML24 CLOSER VIEW AT TOP OF CHIMNEY SHOWING STUCCO, ADOBE, AND STONE OF CHIMNEY, BEAM, RAFTER, VIGA, AND UPPER CORNER OF RETROFITTED FRAMED WALL

On the exterior walls, where the north elevation and adjacent corner adobe is missing and has been infilled with a wood framed and sided wall, the framed wall should be removed and the adobe reconstructed. The lower three feet or so of this wall is banked into the adjacent grade, so at the time of its rehabilitation/ reconstruction, the lower portion should be constructed of concrete, not adobe. The grade at this location, and generally around the building, must be lowered slightly and sloped to provide positive drainage away from the structure. The stucco finish should be recoated, with an additional base coat in areas where it is missing. An analysis of the stucco should be performed. Any other areas where the adobe and/or stucco shows deterioration should be repaired in-kind, most notably at the interior of the southeast corner chimney.

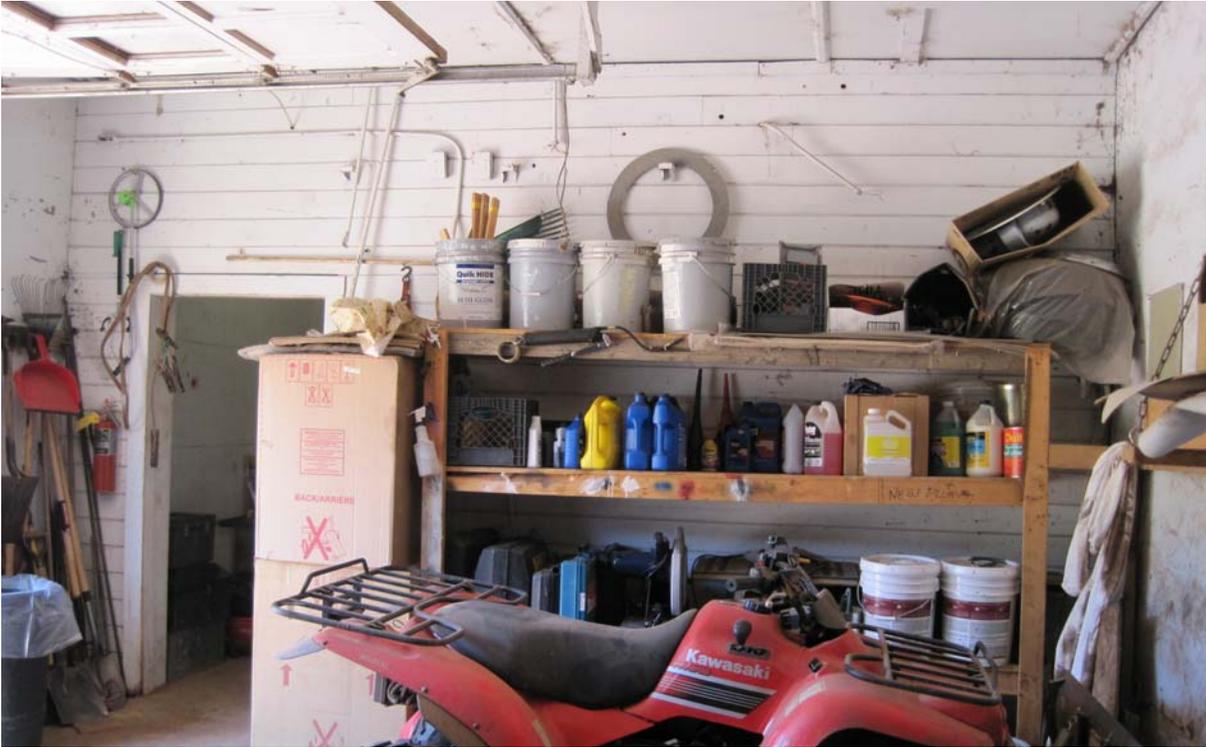
ML25 NORTH WALL OF LARGE ROOM AT CENTER ADOBE PORTION OF BUILDING

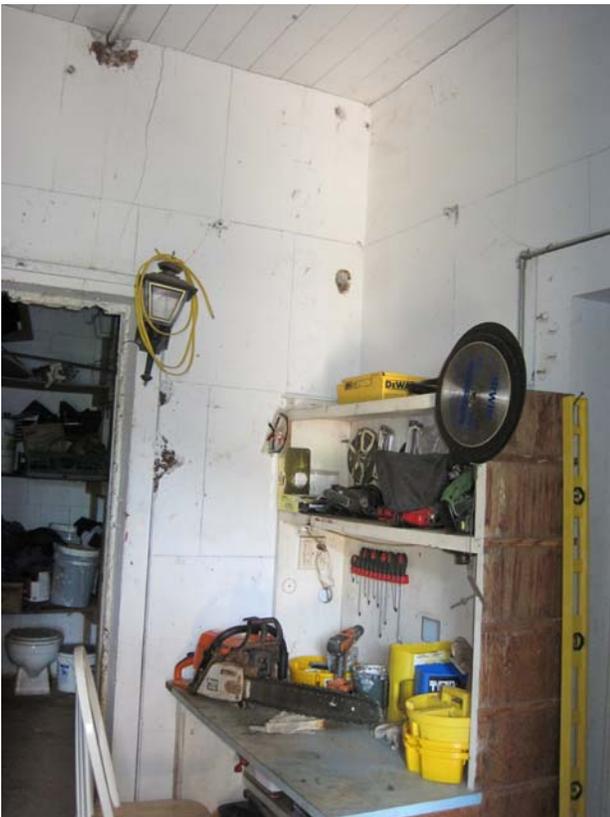
The north rooms of the center section have wood framed demising walls, concrete floors, white painted plank ceilings, and the south wall is sided with shiplap siding and 1x trim. Beyond the lap sided wall, the space is divided into three rooms, all finished with several layers of rectangular cork tiles that are also painted white. The door openings are cased and trimmed but the doors are missing. It appears that these rooms were utilized for a temperature controlled function. The interior finishes are in generally good condition.

ML26 CORK AND OTHER INTERIOR FINISHES AT NORTH CENTER SECTION ROOMS

Interior finishes should be repaired where necessary and repainted.

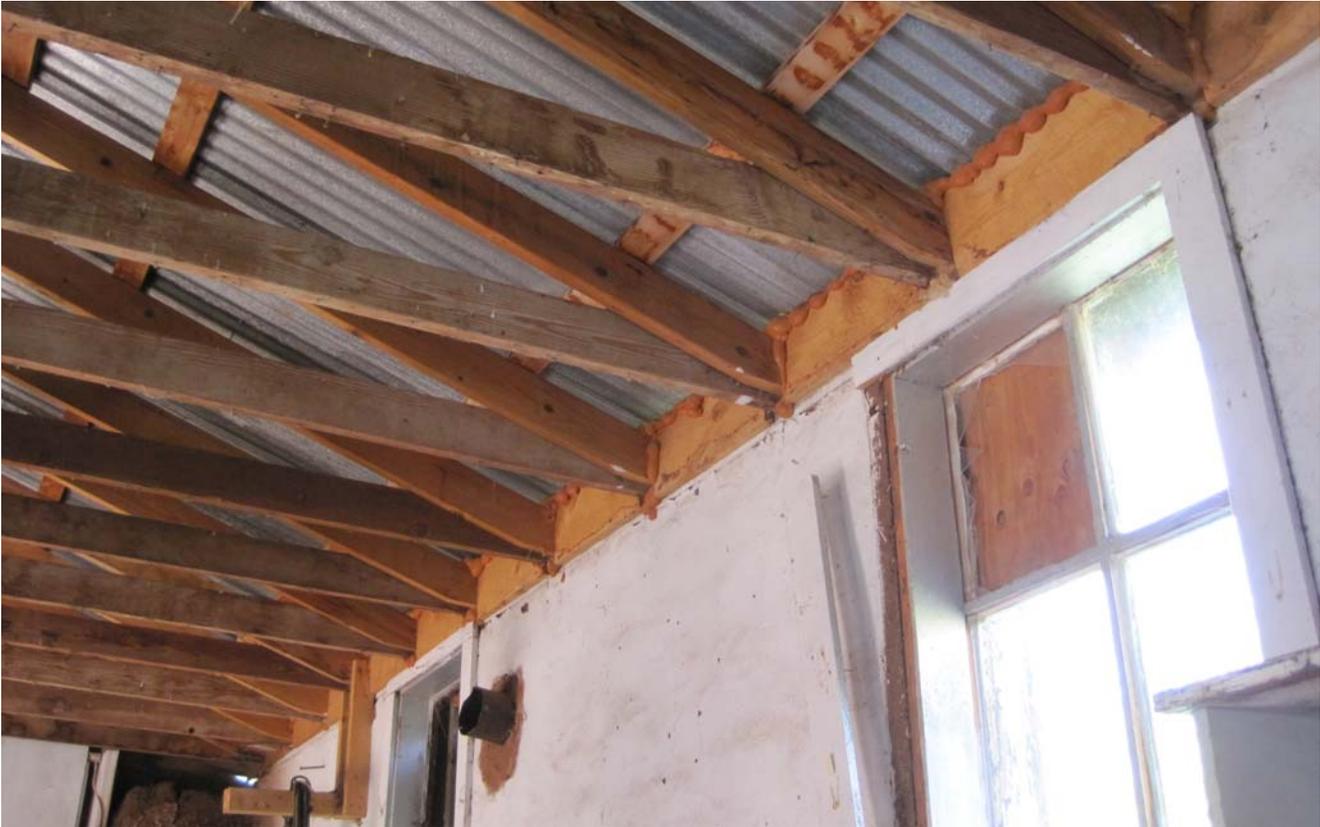
ML30 ROOF FRAMING AND OTHER EXISTING CONDITIONS ON EAST WALL OF NORTH SECTION

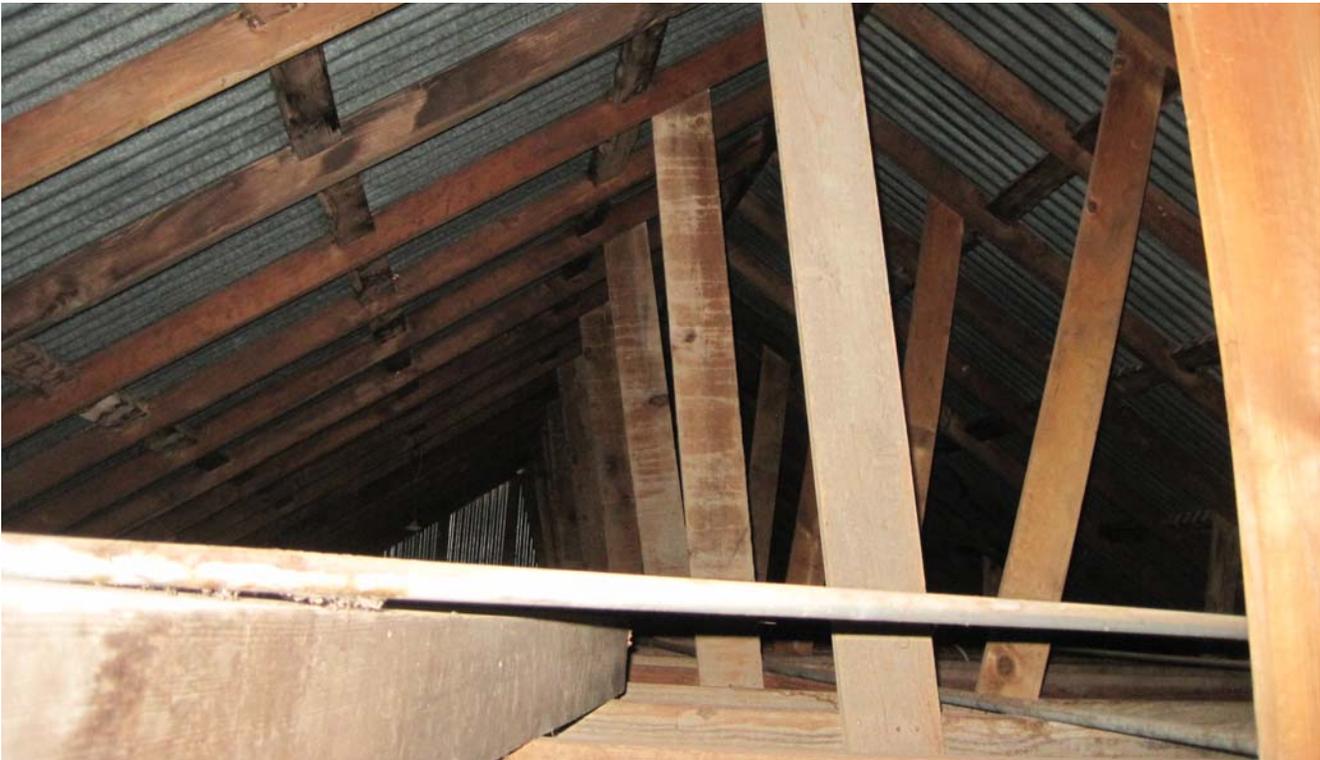
ML31 ROOF FRAMING IN ATTIC ABOVE CENTER ADOBE PORTION OF BUILDING

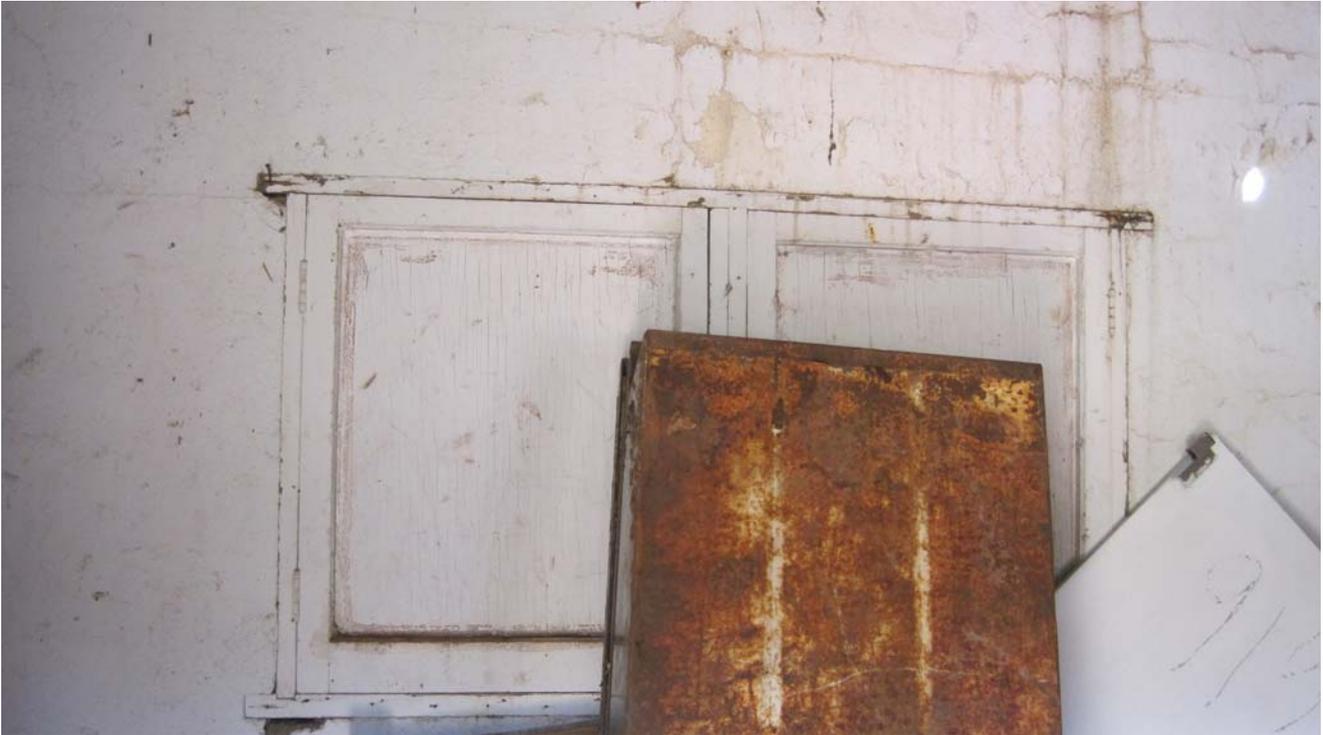
ML32 BOARDED UP WINDOW IN SOUTH STONE SECTION OF BUILDING

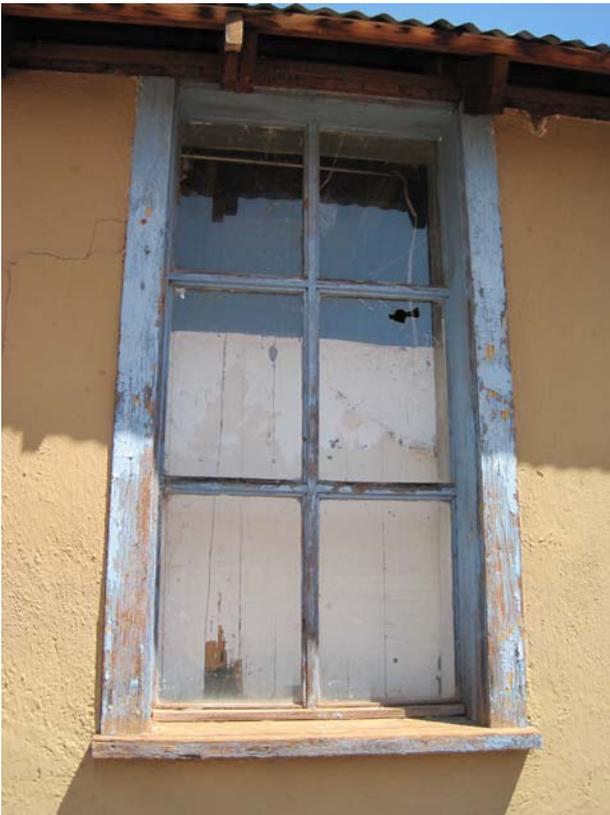
With the exception of the window on the north elevation, which is boarded up, and a one-over-one anodized aluminum operable sash (or storm window), the original taller than wide, wood framed, six-light, three by three, fixed windows still exist. Many of the panes are broken and have either been individually infilled with plywood, or the sashes have been partially or completely boarded up. The frames are largely intact. They are trimmed on the exterior with wood 1x's inset into the stucco parging, and have wooden sills. Some are trimmed with 1x's on the interior, although it is applied to the face of the stucco, not inset. The condition of each individual window was not documented for this report, but they are in generally poor to deteriorated condition, badly weathered and checked, and some of the trim is partially or entirely missing.

ML33 WINDOW ON WEST ELEVATION OF ADOBE STRUCTURE (BEST CONDITION WINDOW)

Windows and trim should be restored or reconstructed if deteriorated beyond repair. The garage doors should be replaced with contemporary doors similar in style and configuration. The passage door, its frame, and its trim should be restored.

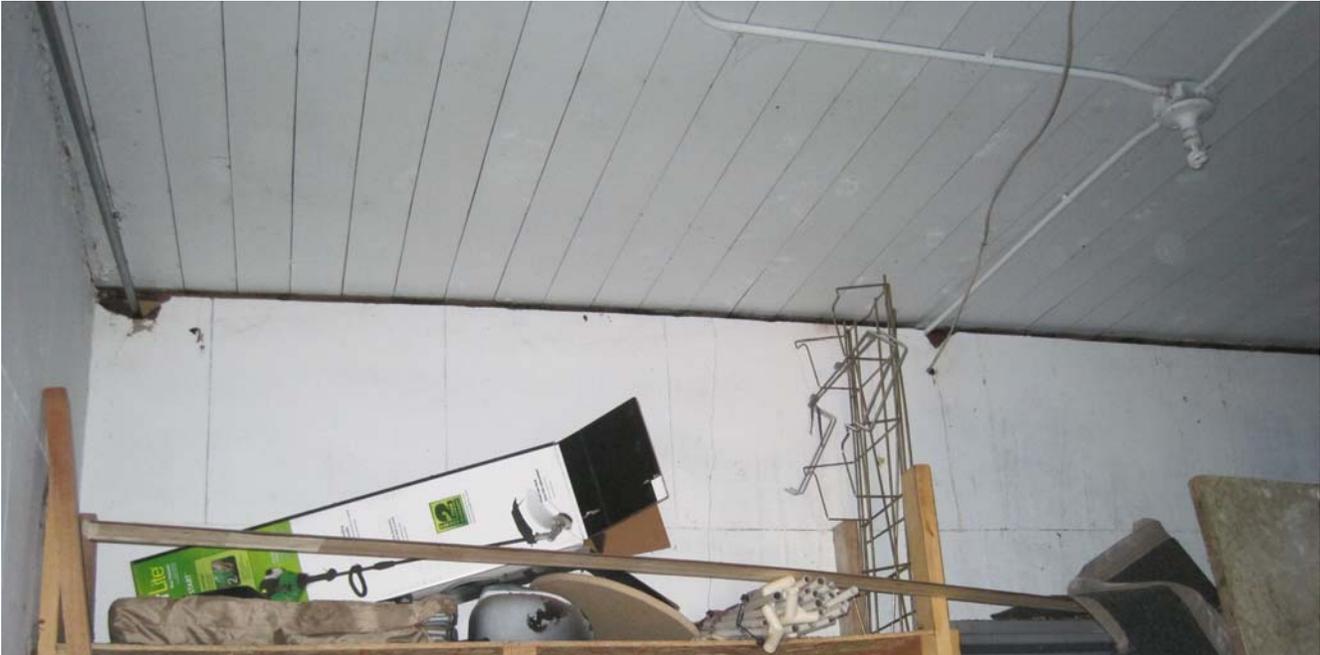
ML35 RETROFITTED ELECTRICAL DISTRIBUTION IN CONDUIT

The electrical system should be evaluated by professionals well versed in the rehabilitation of historic structures, and appropriate repairs and new electrical and mechanical systems and components should be installed in as minimally invasive a manner as is possible. The lighting should be simple and clearly not historic in appearance.

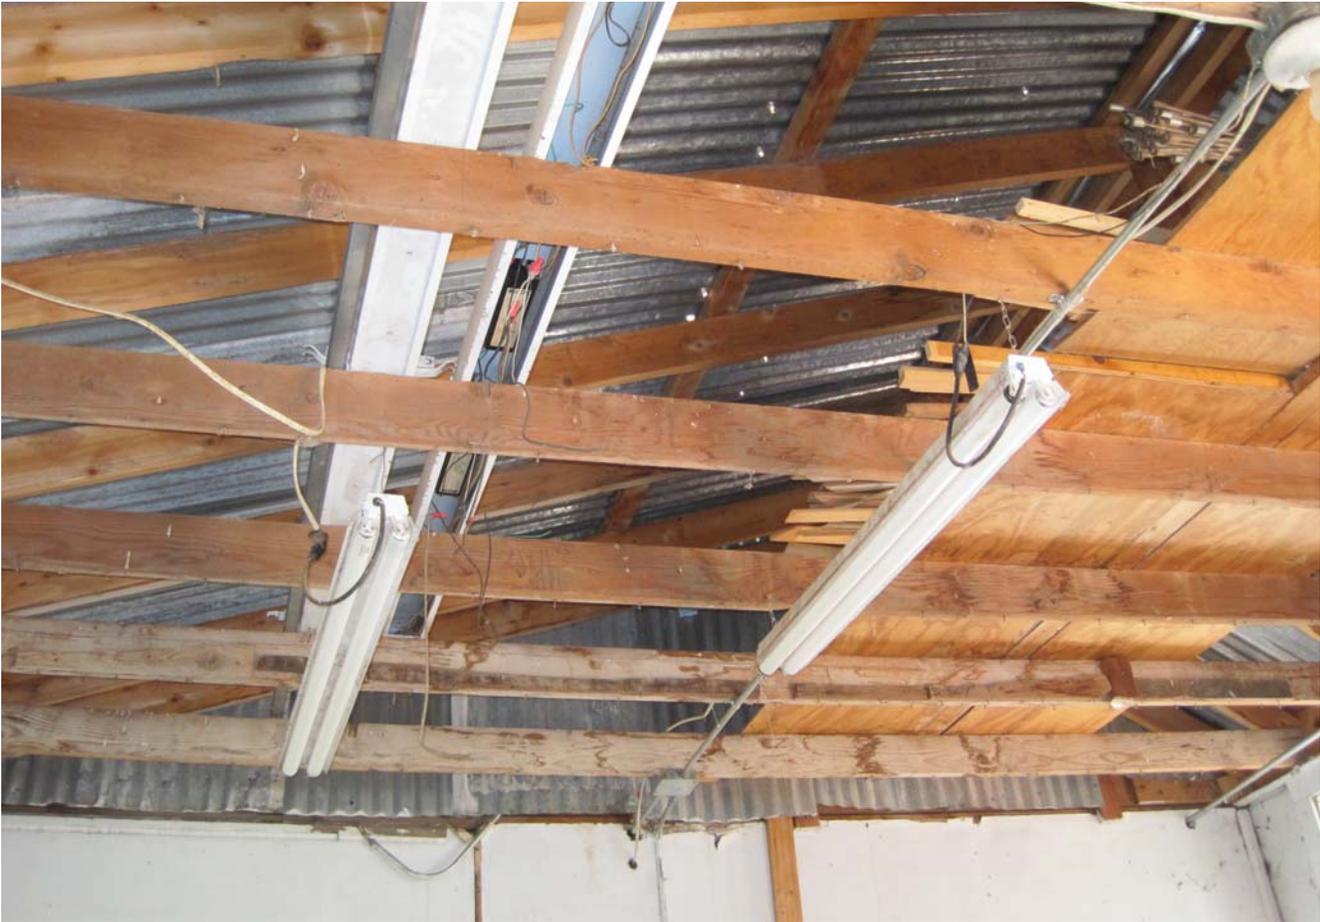
ML36 RETROFITTED ELECTRICAL AND LIGHTING
